***REHABILITATION PLAN***  
***for***  
***LATROBE PARK***

*Prepared for*  
***City of Baltimore, Department of Recreation & Planning***

***March 2002***

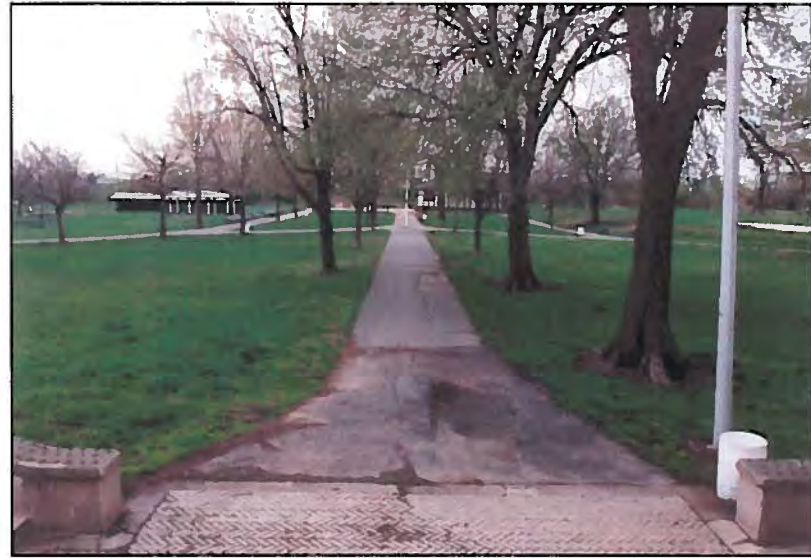
Image 1: View into the park from the grand staircase.

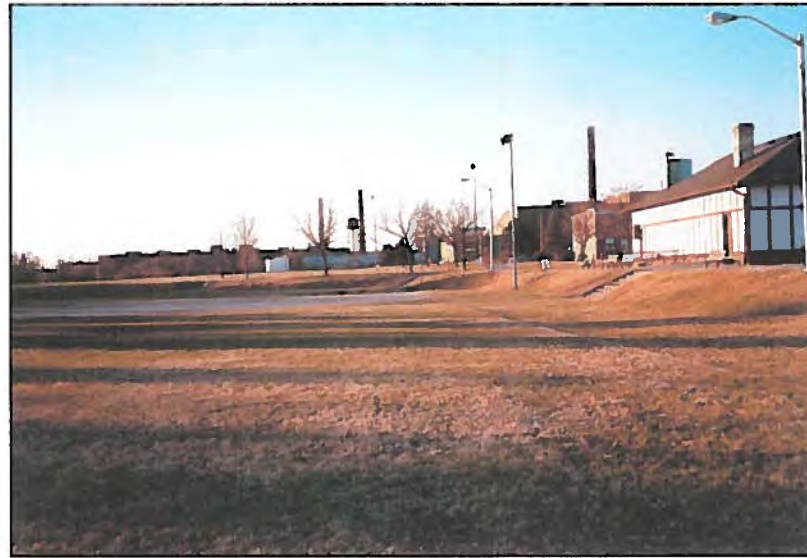
These field steps, in their historic locations, were built as noted on the Olmsted plan for the park and provided a way to access benches that were located on the level of the playing field from the promenade and field house. Refer to *Selected Historic Graphics*, Figure 2, '1907 General Plan for Latrobe Park' and *Existing Conditions Images*, Image 2. The four sets of concrete steps are in fair to poor condition.

Image 2: Sports field, looking west. Note banked edge of field and concrete steps leading to field level.

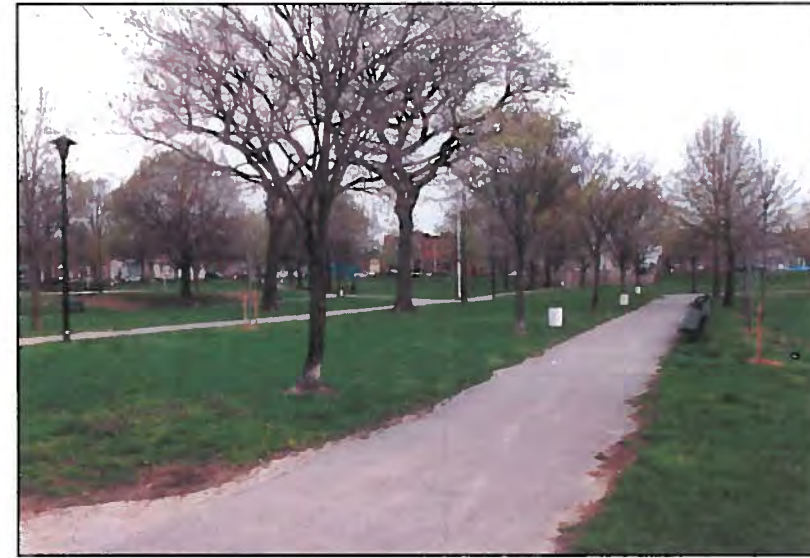
Image 3: Grove in center of park with canopy trees and walks.

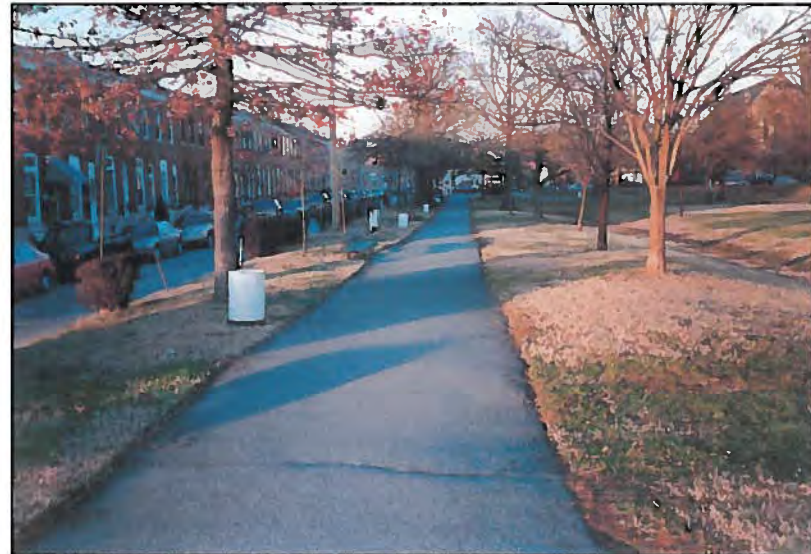
Image 4: Promenade walk on western side of park, looking north.

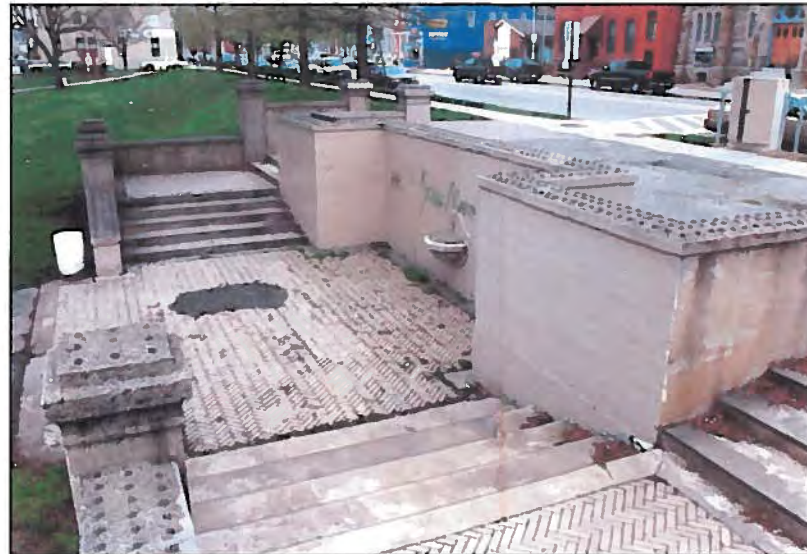
There is only one water feature in the park today. A small lion head fountain and basin is located in the center of the lower wall of the central staircase, but is no longer in working order. Refer to *Existing Conditions Images*, Image 5.

The grand central staircase is located at the northern border of the park along Fort Avenue. Centrally located along this border, it is constructed of concrete and brick in a symmetrical layout. There are two sets of steps, one on either side, which descend to a landing. Each then turns toward the center to a second landing centered behind a retaining wall. A small lion head fountain is located in the center of the retaining wall. The standard size, yellow brick in the landings are laid in a herringbone pattern. Refer to *Existing Conditions Images*, Image 5.

The grand central staircase, designed by the Olmsted Brothers, is an original park feature. The concrete steps are in fair to good condition with some cracks evident on the steps. The brick landings are in fair to poor condition with some brick missing and patches of asphalt. As a central element of the park, this feature provides a distinct entry into the park from Fort Avenue.

Image 5: Center grand staircase on Fort Avenue. Note herringbone pattern of brick and fountain on lower retaining wall.

and should be retained. While the stair exhibits minor deterioration, it can be repaired, maintaining the steps for active use. The upper landing of the staircase, adjacent to the Fort Avenue sidewalk, should be replaced with brick, laid in the historic pattern, to redefine this as an element of the park. It is also recommended that benches be placed along the Fort Avenue sidewalk to provide views both toward the street and into the park, where feasible. The secondary entrances from the northeast and northwest corners of the park provide access for the majority of park users. It is recommended that these entrances be more clearly articulated to upgrade their function and appearance. These three entry areas provide overall views into the park from a slightly higher elevation. Unfortunately the long view beyond the park's southern edge to the Patapsco River has been lost with the construction of the I-395 planted berm. Views into the park, and from the interior to the outside, need to be retained and enhanced.

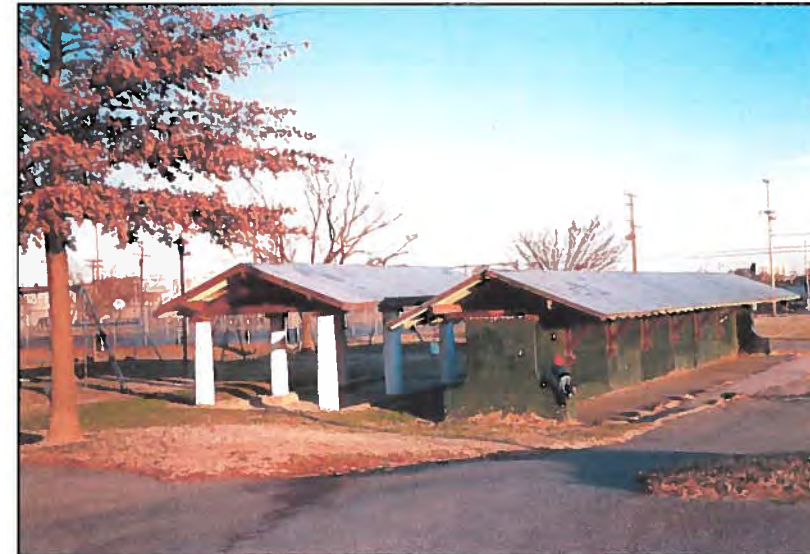
One of the original two covered sand boxes is still in existence. Refer to Image 6 of the *Existing Conditions Images*. Designed and built with a trellis covering, this structure provided a place for children to play in sand with dappled shade. This distinct element of the park is an original feature and could be considered for uses other than a sand box. This structure is discussed in detail in Section B, Architectural Review, below.

Image 6: Covered seat and sand box at southern end of playground.

The covered seat is also an original park feature, located east of the Field House. The 75' by 16' structure, which was also constructed c.1905 as part of the Olmsted Brothers plan, is another Craftsman-era gem. Refer to Image 6 of the *Existing Conditions Images*. It consists of a heavy poured concrete base with a rough finished texture; timbered buttresses, supports and rafters; wide tongue and groove underlayment; and a flat-seamed metal roof. The original bench seating, which ran the entire length of the wall on each side, has long since been removed.

Through visual examination, the covered seat was found to be in structurally good condition, though marred with graffiti.

The concrete base is solid, with only minor damage to its textured finish. The timbered structure supporting the roof is also in good condition, with only minor deterioration to its components. The flat-seam tin roofing appears to be sound, with no sign of leakage observed. The covered seat is still located in its historic location and retains much of its historic character, with the exception of the missing wooden benches.

The covered sand box is also an original park feature, located east of the Field House and adjacent to the covered seat. Refer to Image 6 of the *Existing Conditions Images*. The 25' by 19' structure, constructed c.1905 as part of the Olmsted Brothers plan, was also originally designed in the Craftsman style. The remaining structure is one of two open-roofed structures that originally stood end to end. The covered sand box is contained within a concrete-curb, which also forms the base for the Pergola. Eight heavy concrete pillars, in a simplified Doric style, are topped with wood timber framing. Once open to the sky, a roof has been added atop the framing, consisting of modern plywood substrate and asphalt shingle roofing.

Through visual examination, the sand box was found to be in basically good structural condition. The concrete base and columns are solid. The timbered structure supporting the roof is also in good condition, with only minor deterioration to its components. Several of these components have already been replaced. The roofing substrate consists of modern plywood, and recently installed asphalt shingle roofing appears to be sound, with no sign of leakage observed.

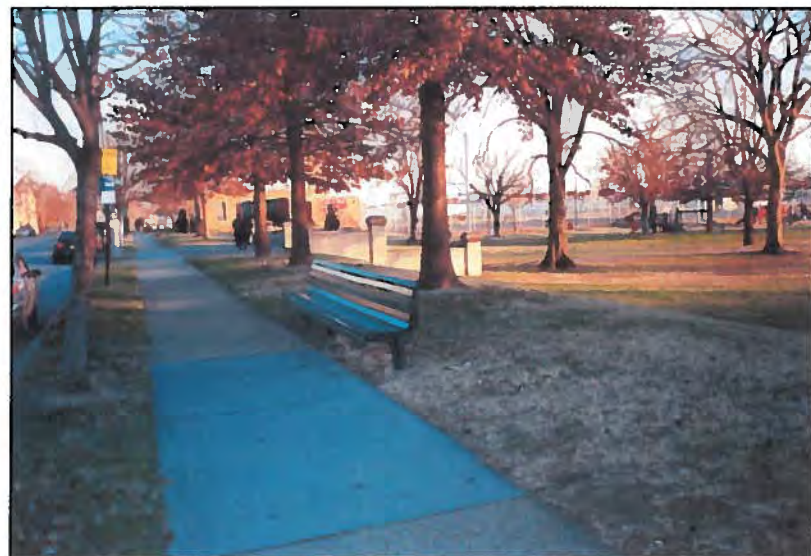
Image 7: View looking east along north/Fort Avenue side of park, showing character of front edge of park. Note style of bench.

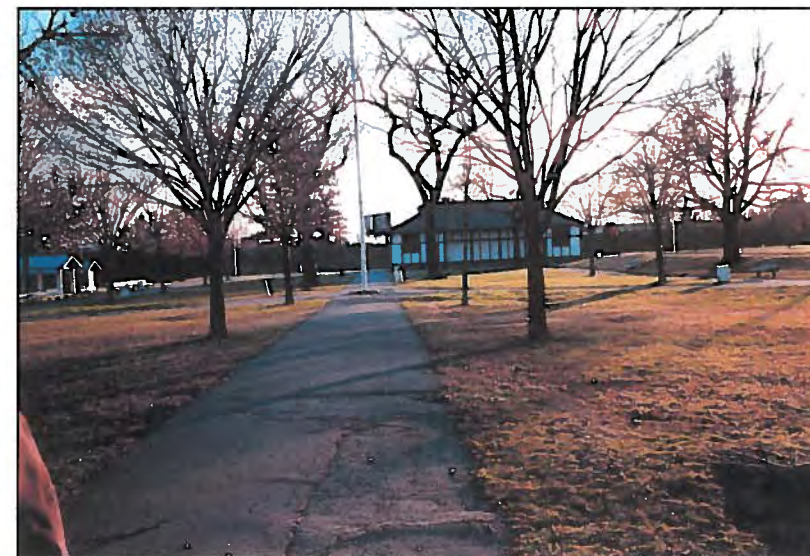
Image 9: View of Field House from center path, looking south.
