CRIMEA AREA MASTER PLAN GWYNNS FALLS/LEAKIN PARK Baltimore, Maryland

Prepared for Recreation & Parks, City of Baltimore

Prepared by Heritage Landscapes Preservation Landscape Architects & Planners Charlotte, Vermont & Norwalk, Connecticut

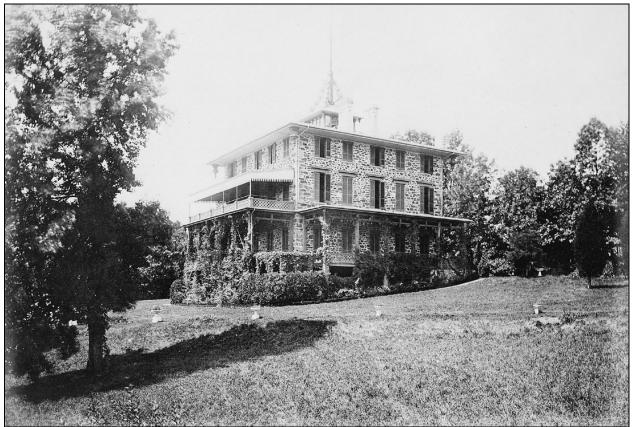
Figure II.1 Historic image of Crimea Mansion and grounds, circa 1901 with urns placed along a walk and vines covering the porches. Courtesy Maryland Historical Society, Crimea-R-Mansion-MHS-Z24-1177.

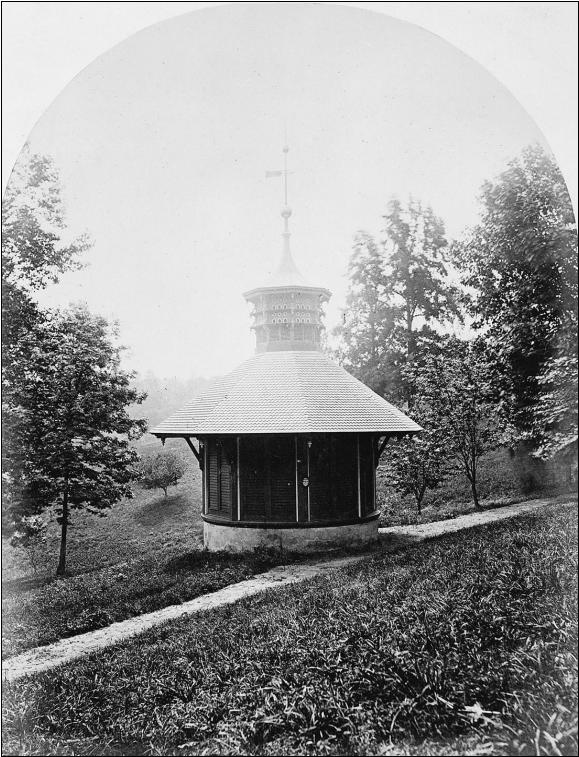
Figure II.2 Historic image on the Crimea grounds of an ornamental Gazebo with louvered doors, while small openings in the cupola appear to indicate a pigeonaire function, circa 1875 photograph. Courtesy Maryland Historical Society, Crimea-R-Gazebo-MHS-Z24-1178.

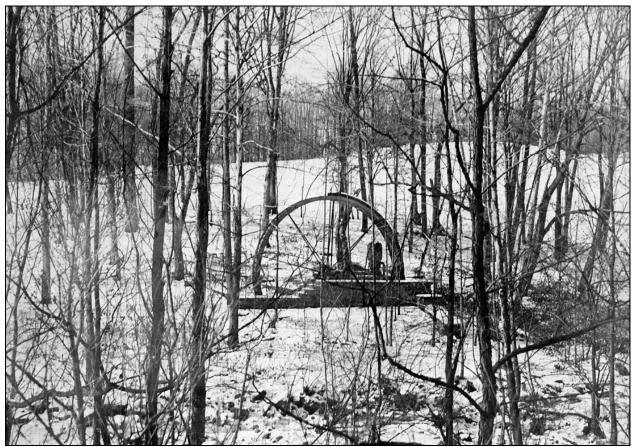
Figure II.3 Historic image of waterwheel constructed in the late 1850s on the Crimea grounds, circa 1875 image. Courtesy Maryland Historical Society, Crimea-R-Gazebo-MHS-Z24-1181.

Former water features are also apparent in the landscape. The historic iron Water Wheel shown in image "Area 4: Historic Water Wheel" was used to generate power for the former estate. This enormous metal wheel is positioned in a concrete foundation alongside the river. The water channel, which operated the wheel, is no longer apparent. A foundation of a springhouse located along the wooded trail northwest of the picnic shelter is less noticeable. The springhouse which once stood upon this brick foundation can be seen in Chapter I.

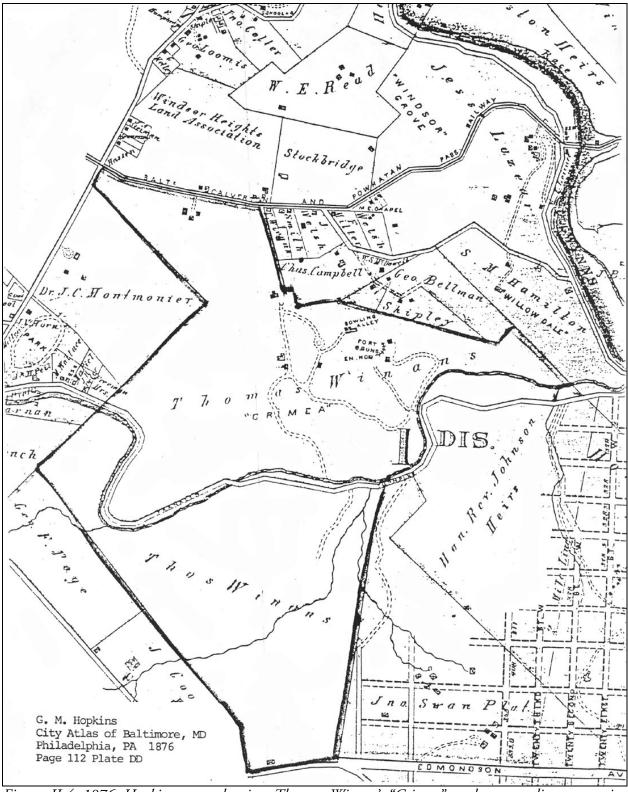
Figure II.4 1876 Hopkins map showing Thomas Winans' "Crimea" and surrounding properties. Courtesy National Register Nomination, Kurtze. CRI-Hopkins.1876-Map.

The earliest graphic record located that captures the entire Crimea Estate is an 1876 map (see Figure II.4).¹³ This image shows Thomas Winans' "Crimea" and the copy included here highlights the property boundaries with a darker line. The irregular boundary of the property is evident, as are some aspects of the internal circulation system. While the entry drive is not shown extending northward, the circuit drive around which the structures are clustered does appear, as do several driveways to the south extending toward the creek and public road. The Franklin Turnpike crosses the property from east to west paralleling Dead Run, a large creek. Clusters of structures likely to be the fort, Chapel, Barn, Honeymoon Cottage, and Crimea Mansion are shown. There are also a few labels included that identify the Bowling Alley, Fort and Guns, the abbreviation "En Hos", possibly indicating an Engine House. At this time smaller neighboring farms and house lots abutted the Crimea along Baltimore Calvary & Powhatan Pass, now Windsor Mill Road. The surrounding parcels are of varying sizes but none appear to be as large as the Crimea acreage.

The oval Loop Drive is the main circulation element of this portion in the Crimea area of Gwynns Falls/Leakin Park. It can be seen in the 1927 aerial photograph (*AP-1927*) and on the 1876 Hopkins Map from the City Atlas of Baltimore (Figure II.4). The Loop Drive is also shown in the images "Area 2: Mansion Drive, View North Toward Carriage House" and "Area 2: Mansion Drive, View Toward Gazebo" on image sheet *ECP-1*.

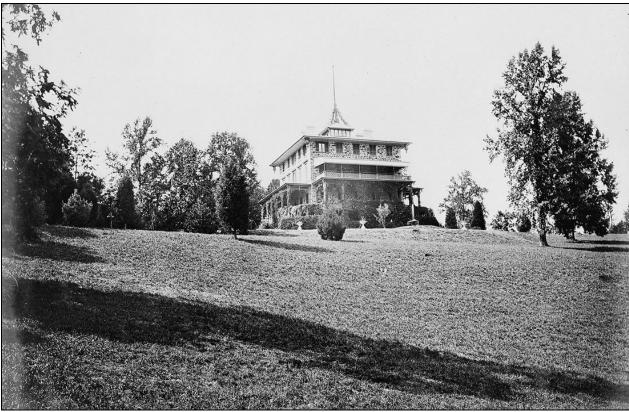
Figure II.5 Landscape around the Crimea Mansion, circa 1901, showing sloping lawns, individual trees around the house and detailed elements near it. Courtesy Maryland Historical Society, Crimea-R-MansionLandscape-MHS-Z24-1176.

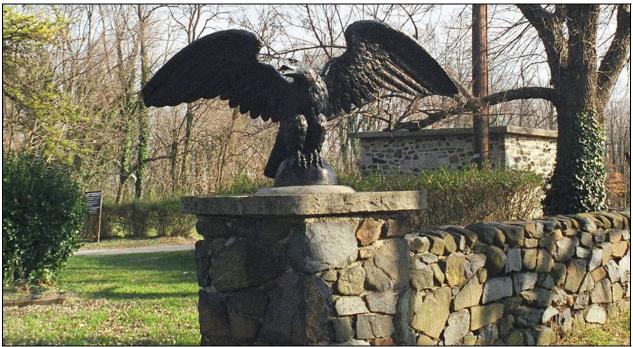
Figure II.7 The Winans cast-iron eagle atop the entry stone wall pier. Courtesy Heritage Landscapes, 2004, CRI-Eagle-Gate.

Historic records indicate that in 1928 the Entry Piers of the North Gate to the Crimea Estate along Windsor Mills Road featured two stone gate piers with two cast iron eagle sculptures atop; one of the eagles is reportedly moved from Alexandroffsky, the Winans' city home, to its new location atop the second pier (see Figure II.7).¹⁷ The Mansion loop is also relatively open. Trees are placed in an informal, sporadic row along the entry drive. Individual trees, clusters and a row of small trees are observed within the Mansion loop. There are other small clearings near the Mansion core while the remainder of this irregularly shaped property has a relatively dense woodland cover.

Eagle Drive, located .14 miles east of the ball field entry drive on Windsor Mill Road and marked by a pair of Crimean eagles atop stone piers, maintains its historic alignment as evidenced in both *AP-1927* and earlier "Map of Thomas Winans 'Crimea' by G.M. Hopkins from the City Atlas of Baltimore 1876," (Figure II.4) This drive is a primary entry to the Crimea Area of Gwynns Falls/Leakin Park and is the sole source of access to the Crimea Mansion and other historic buildings. Directly east of Eagle Drive is a large gravel/blacktop parking area with an access drive that directly links the lot to Windsor Mill Road. Entry and exiting movements throughout the Crimea Area of the park are slightly confusing due to the narrow width of Eagle Drive, 14'-0" wide, and the existence of a second access road to the parking area. Four tennis courts are located east of Eagle Drive, and just south of the parking area.

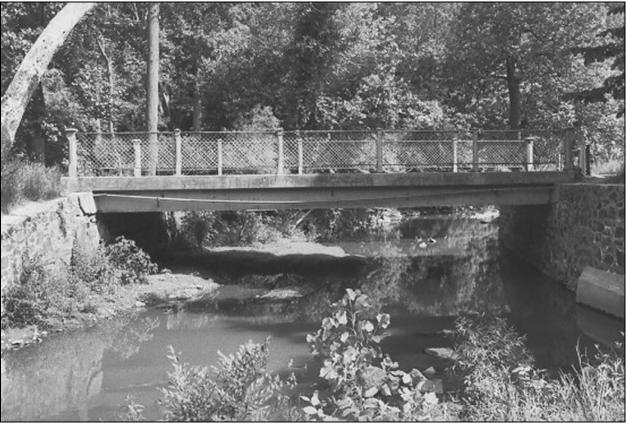
Figure II.8 A reconstructed bridge over Dead Run using the Winans era railings. Courtesy National Register Nomination, Kurtze, CRI-R-Bridge.
