A MASTER PLAN FOR PATTERSON PARK IN BALTIMORE, MARYLAND

CITY OF BALTIMORE DEPARTMENT OF RECREATION AND PARKS  
CAPITAL PROJECTS AND PLANNING DIVISION

JANUARY 1998

*Rhodeside and Harwell, Incorporated*  
*Delon Hampton & Associates, Chartered*  
*A. Morton Thomas and Associates, Inc.*  
*Charles E. Beveridge, Historical Consultant*

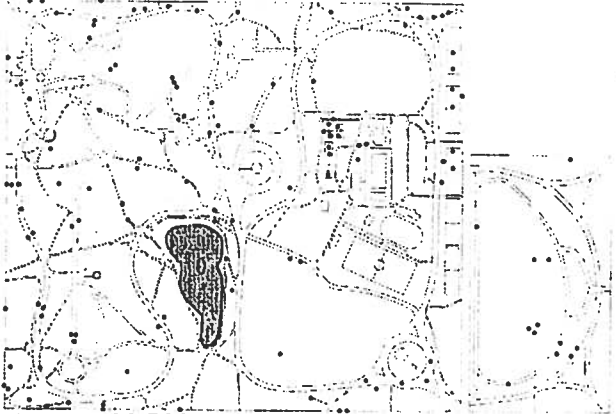
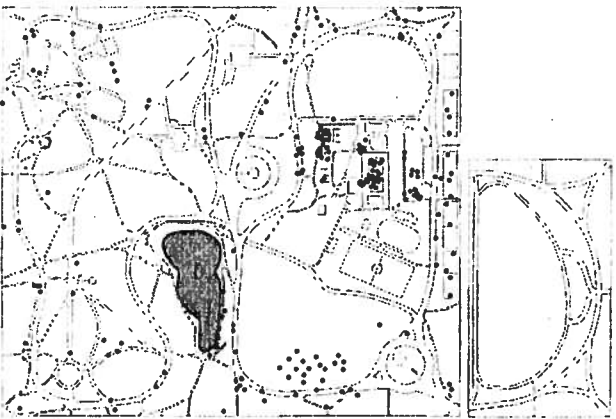
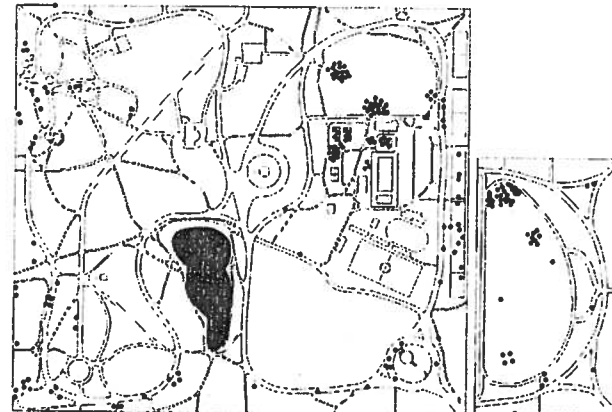
figure 13

PARK USE FOR SUNDAY, JULY 9, 1995
