***REHABILITATION PLAN***  
***for***  
***LATROBE PARK***

*Prepared for*  
***City of Baltimore, Department of Recreation & Planning***

***March 2002***

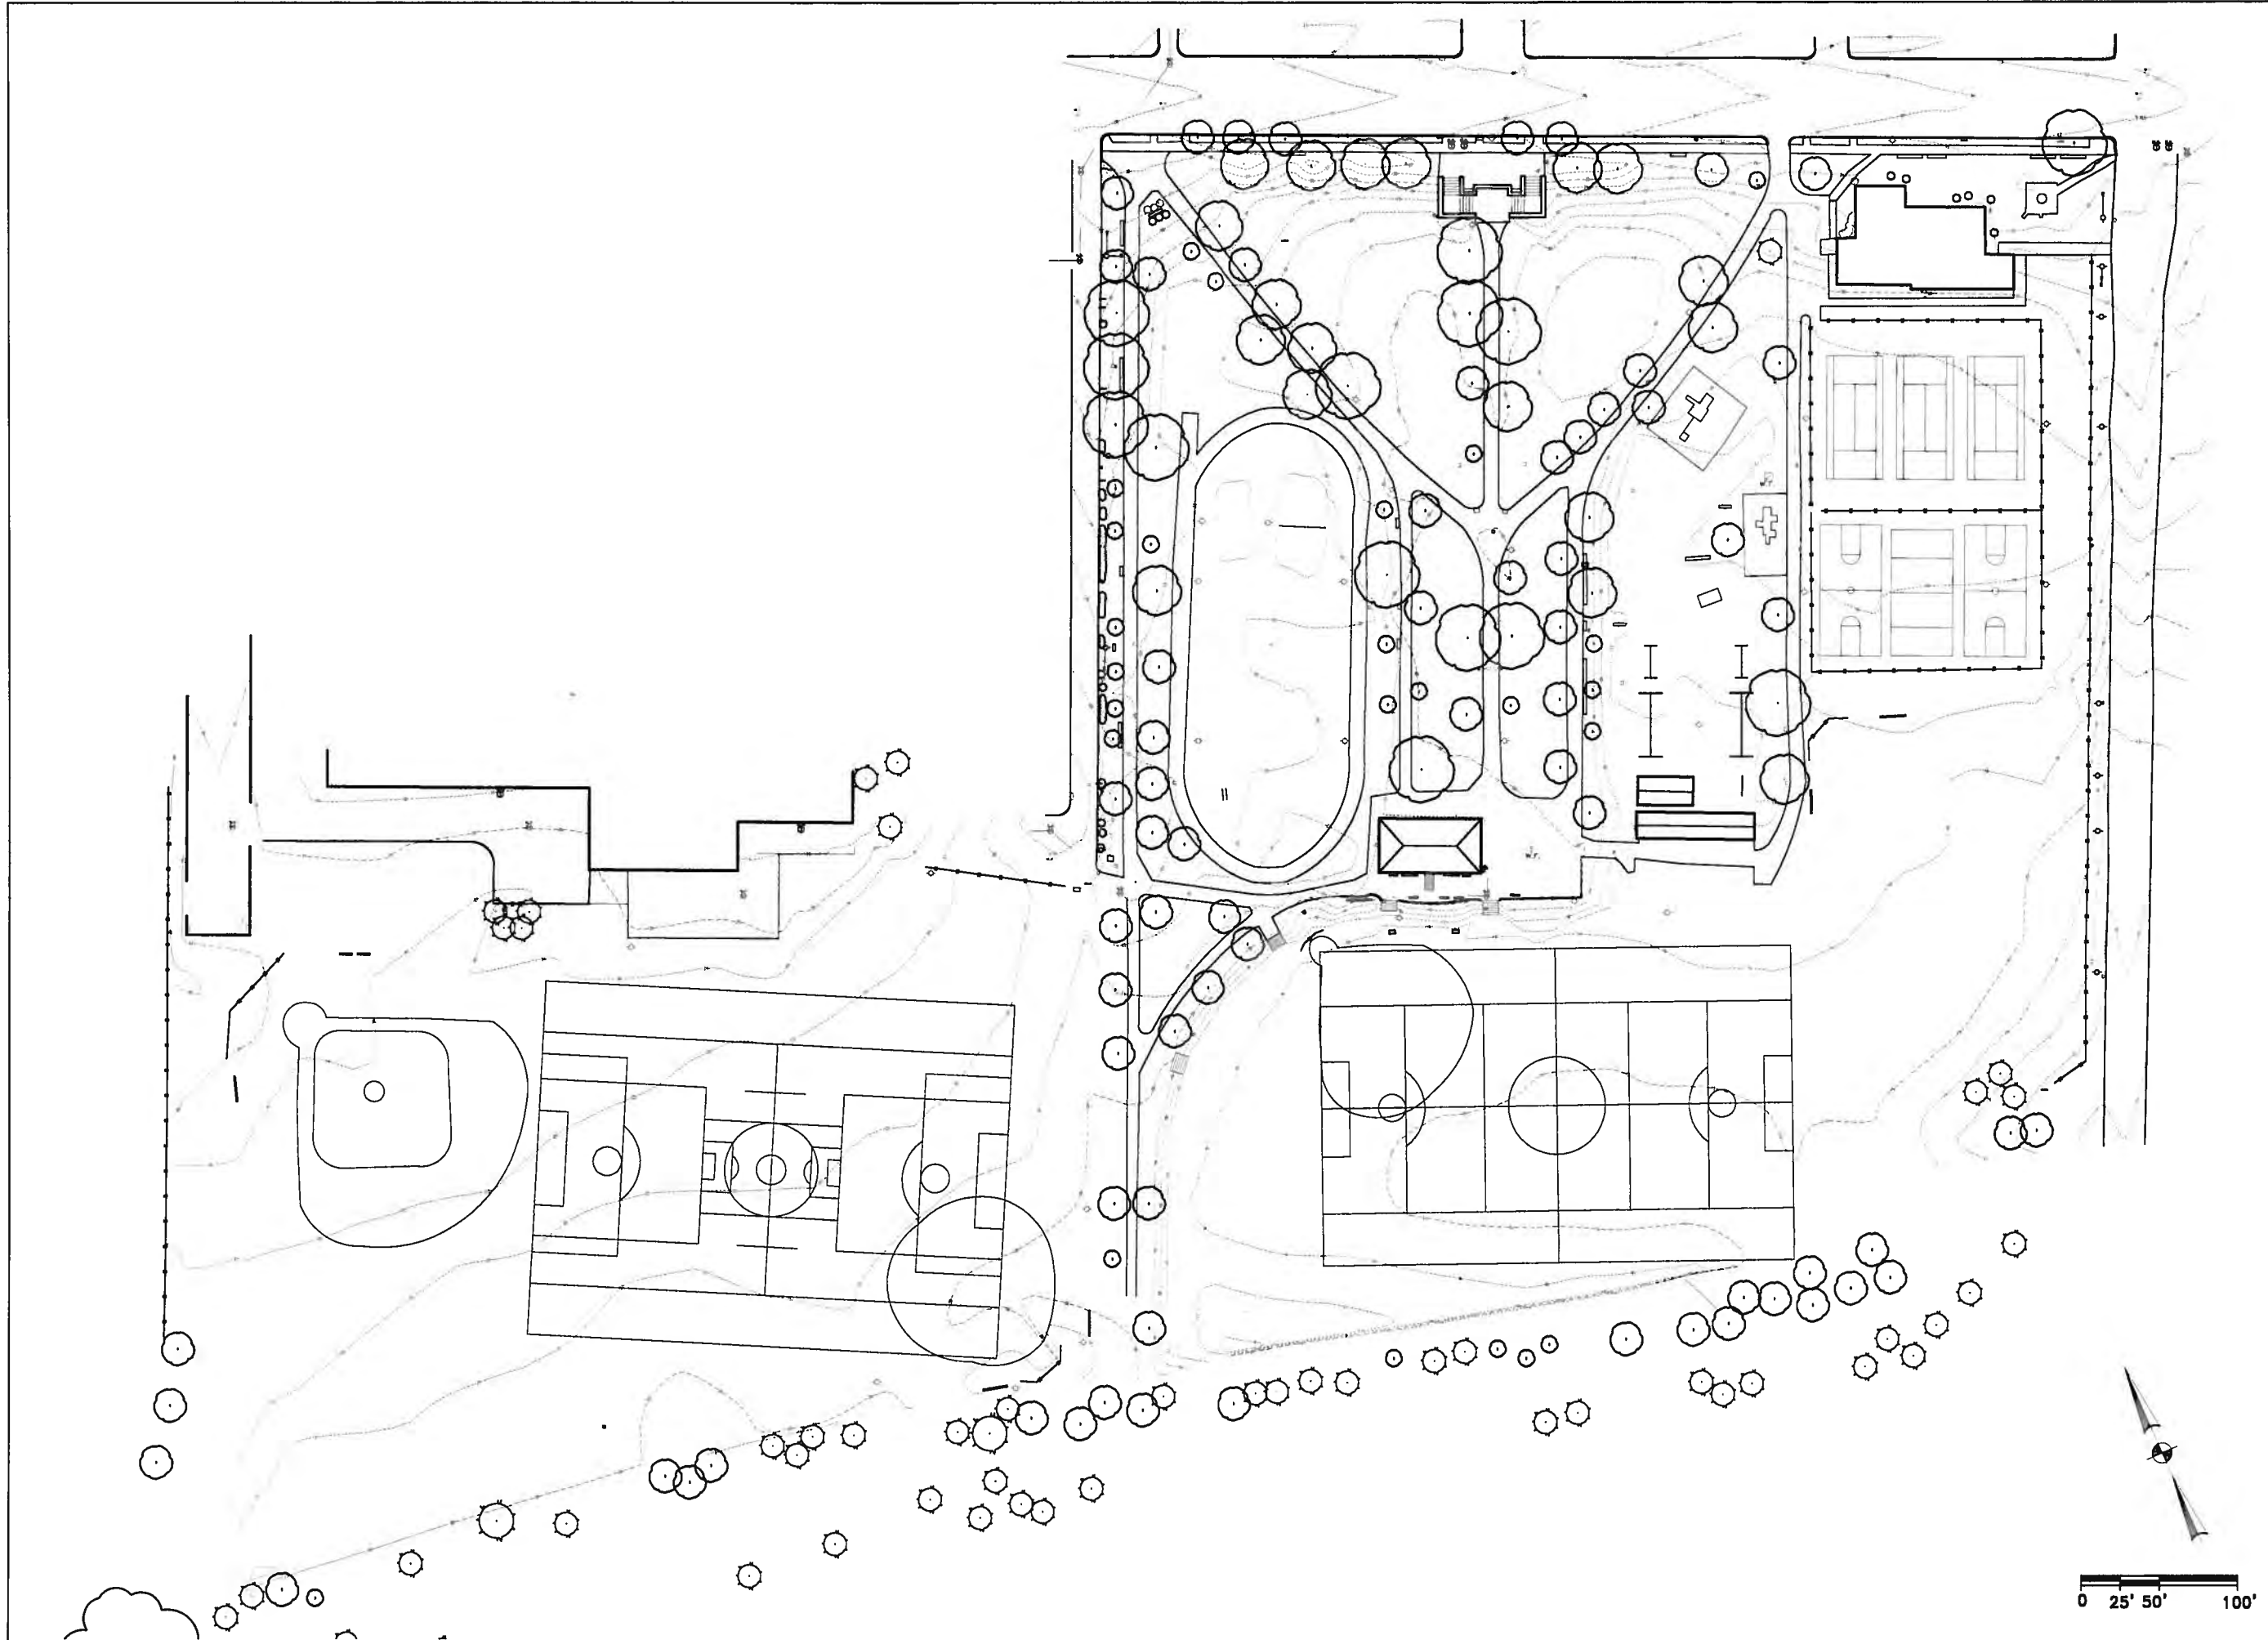
The center park entrance is pronounced with a grand staircase with two secondary side entrances from the northeast and northwest corners of the park. The staircase is constructed of concrete and brick laid in a herringbone pattern. The stairs are in fair condition with some degradation of the concrete treads and missing or broken brick on the landings. The side entrances are understated asphalt walks that slope gently into the central area of the park. A wooden sign is located at the west entrance noting the Victor P. Dooa Sr. Memorial Fields. A vehicular entrance to the park, for maintenance purposes, is located in the southeastern corner of the park at Andre Street. This entrance is signed "Vehicles Prohibited beyond this Point, Dept. of Parks & Recreation". Views into the park are directed from the corner entrances and the central staircase with the placement of canopy trees and walks. Refer to *Existing Conditions Images*, Image 1. Views are terminated on the south end of the park by the I-395 berm.

These field steps, in their historic locations, were built as noted on the Olmsted plan for the park and provided a way to access benches that were located on the level of the playing field from the promenade and field house. Refer to *Selected Historic Graphics*, Figure 2, '1907 General Plan for Latrobe Park' and *Existing Conditions Images*, Image 2. The four sets of concrete steps are in fair to poor condition.

Image 1: View into the park from the grand staircase.

Image 2: Sports field, looking west. Note banked edge of field and concrete steps leading to field level.

Image 3: Grove in center of park with canopy trees and walks.
