# Riverside Park

## Master Plan

**Baltimore City Department of  
Recreation and Parks**

**Mahan Rykiel Associates, Inc.  
GWWO Architects, Inc.**

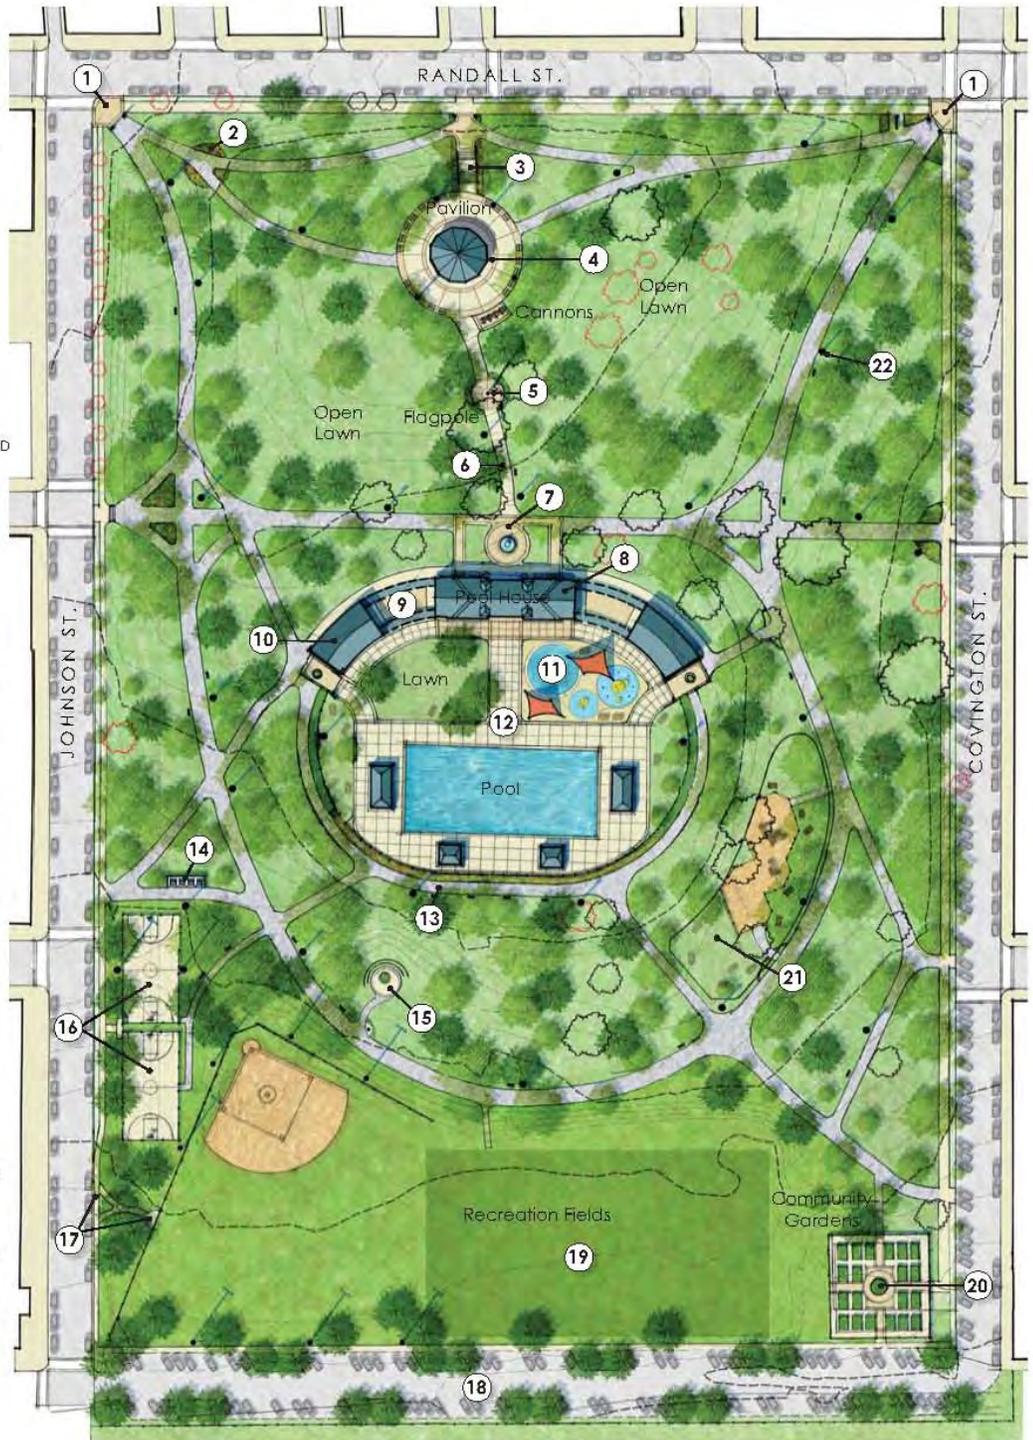
# EXHIBIT A: ILLUSTRATIVE MASTER PLAN

- 18 POTENTIAL FUTURE PARKING, COORDINATE WITH EXISTING RAILROAD
- 19 RENOVATE EXISTING SPORTS FIELD AND PROVIDE ADEQUATE DRAINAGE
- 20 POTENTIAL COMMUNITY GARDEN SPACE WITH INDIVIDUAL PLOTS, ORNAMENTAL FENCING AND WATER ACCESS

- 21 EXTEND EXISTING PLAYGROUND PERIMETER TO THE SOUTH PROVIDE ADDITIONAL PLAY EQUIPMENT AND PICNIC TABLES
- 22 REPLACE EXISTING PARK LIGHTS (COBRA-HEAD STYLE) WITH PEDESTRIAN SCALE BALTIMORE CITY STANDARD LIGHT FIXTURE

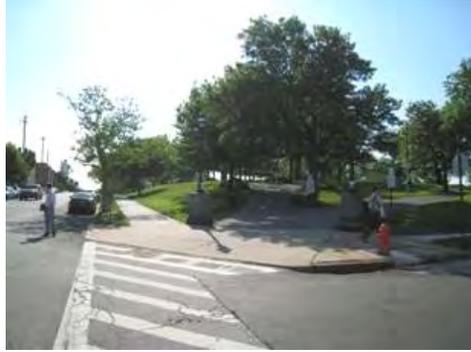
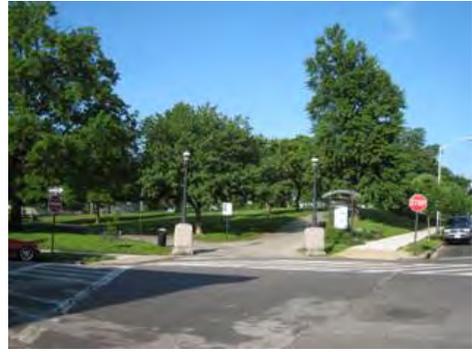
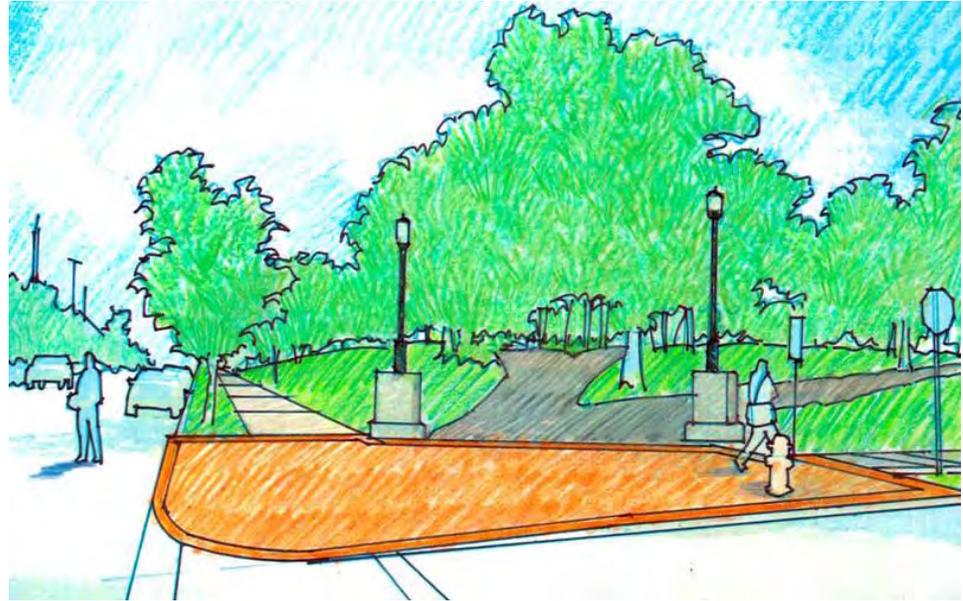
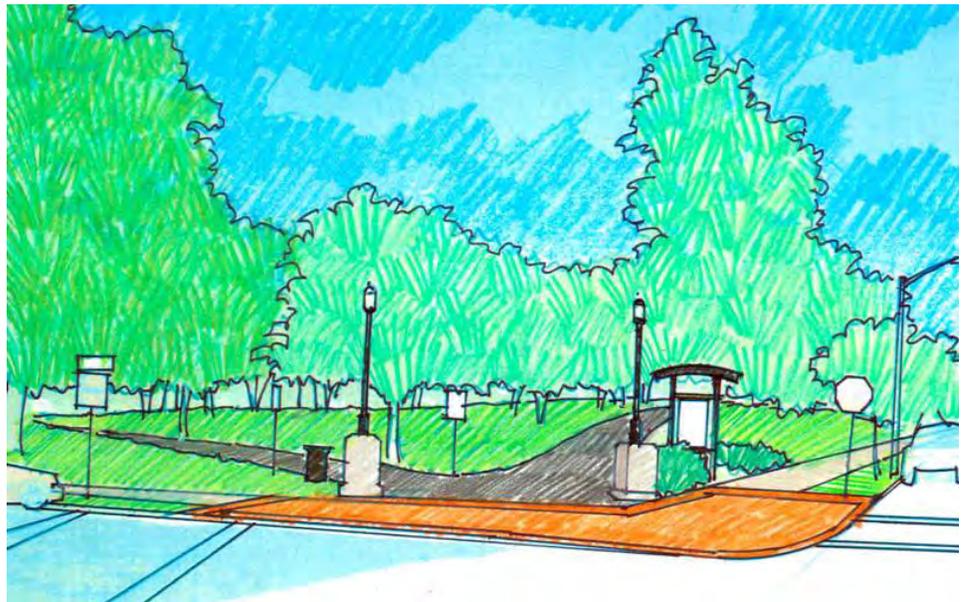
*The above photographs (existing conditions) and illustrations show the potential for distinguishing the corner entrances along Randall Street with new curbing and brick paving.*

- **Accent Paving at Corner Entrances (#1):** Distinguish the division between sidewalk and road by adding a curb and delineate the entrance area with brick paving to reflect the historic brick paving that is still evident in places at the main park entrance.
- **Main Park Entrance (#3):** Provide a field of brick paving and replace the existing hedge with new low ornamental planting.

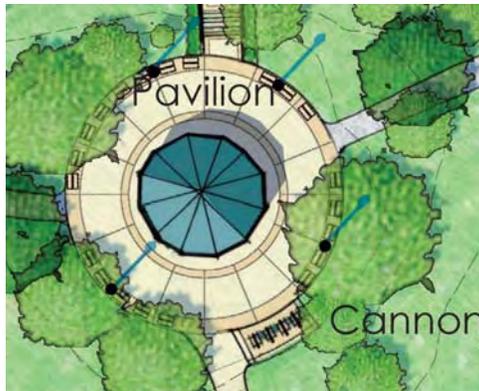
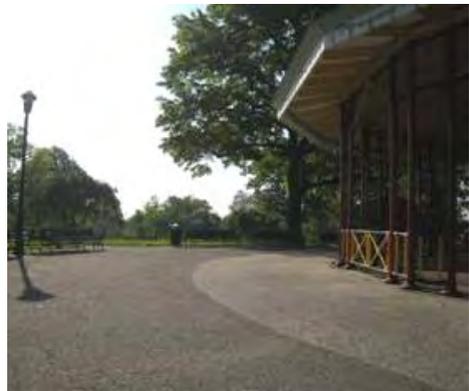
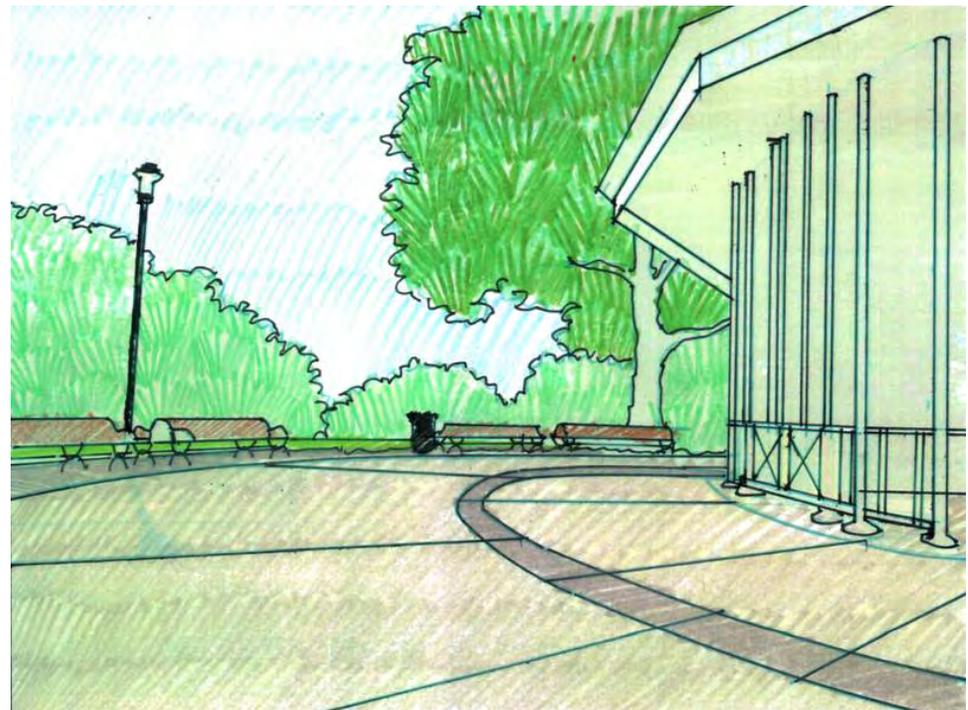
*The above photograph (top right) shows the existing pavilion plaza. The drawings (top left and bottom) illustrate the potential scoring concept for the new paving around the pavilion. Three different concentric zones highlight a pavilion zone, bench zone and walkway zone.*

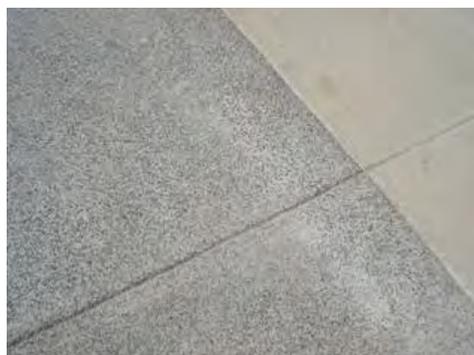
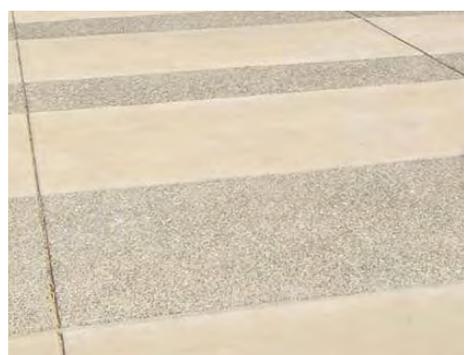
*The above photographs illustrate a potentially subtle paving pattern that can be achieved by using a combination of broom finish and exposed aggregate concrete.*

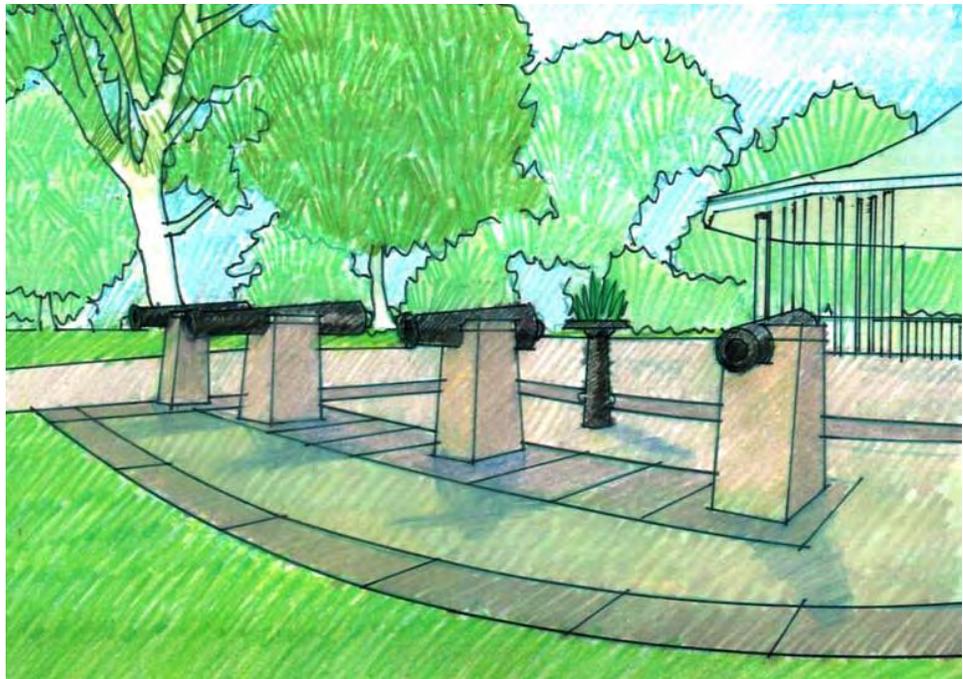
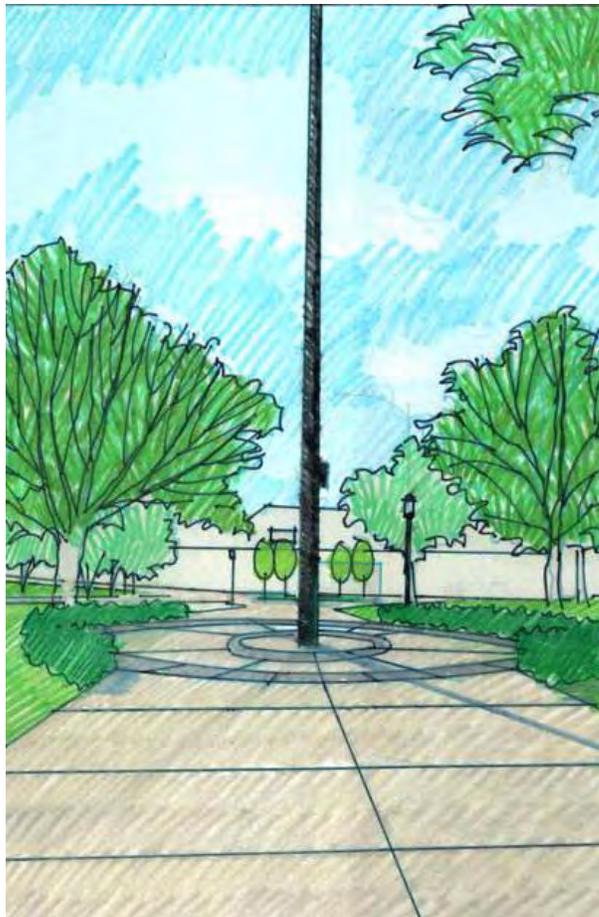
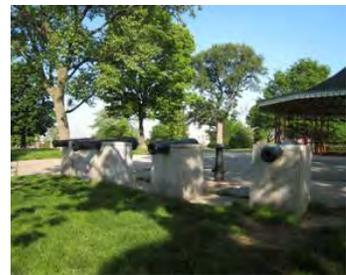
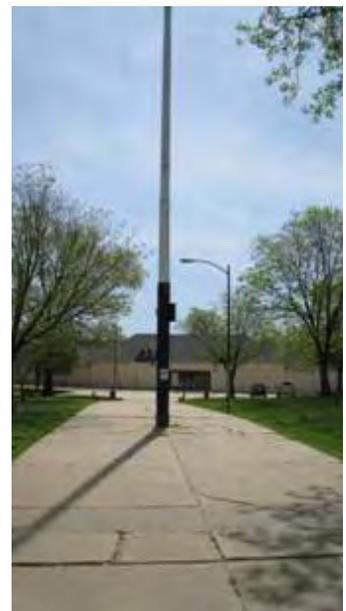
*The two photographs show how the existing flagpole and cannon memorials lack a setting. The illustrations show how expanded paving areas can be used to create more significant settings for these historic park elements.*

- Extend the paving out to encompass the entire memorial. The paving should be different from the pavement surrounding the pavilion to distinguish the setting for the memorial.
- Consider new bases for the canons themselves, constructed of a stone, pre-cast or metal material. Like the existing granite-clad bases, they should be simple and clean in design.
- Provide interpretive signage near the cannon memorial. The signage should be a low panel that doesn't obstruct views.

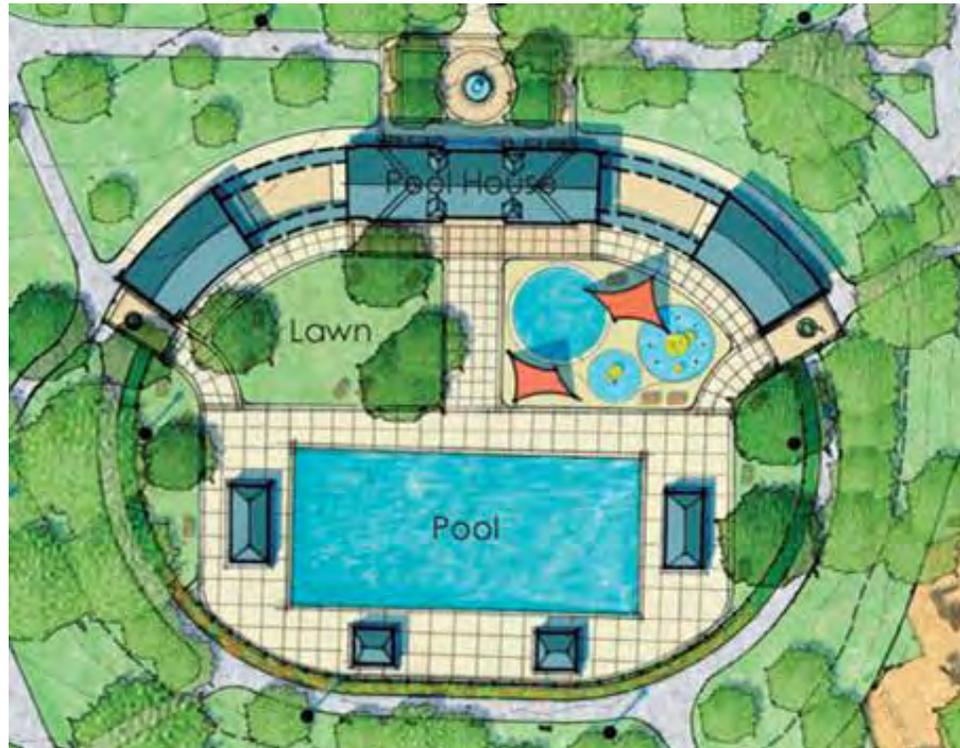
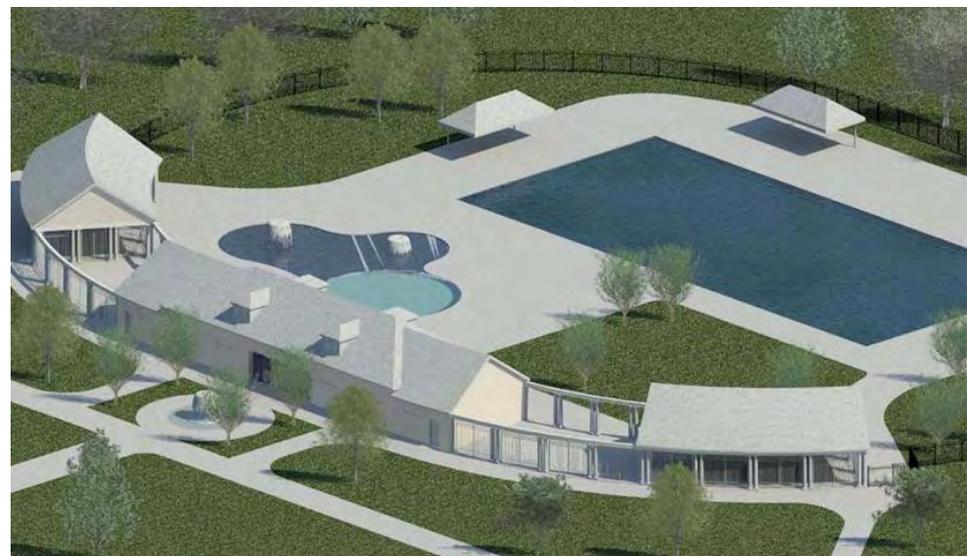
*The above illustrations show how the existing pool house form can be maintained while making it more "transparent". The wings will be modified to include open pavilions and courtyards. The pool grounds will be renovated to include a new splash pad and wading pool along with renovated grounds.*

- **Entry Plaza (#7):** Reduce the paved area at the pool entrance and create an attractive plaza area with new paving and planted areas.
- **Pool House Renovation (#8, #9 and #10):** Remove the existing pool house wings and replace with open pavilions and courtyards. The pavilions and courtyards will allow for improved visual connection between the north and south halves of the park and will provide greater flexibility for events and facility rental.
- **Splash Pad and Wading Pool (#11):** Remove the existing wading pool and replace with a combination splash pad and wading pool.
- **Pool Deck Renovation (#12):** Renovate the existing pool area with new paving, grassy picnic areas and the provision of shade in the form of shade structures and trees.

- Maintain an open walkway centered on the central pool house building. This will be in place of the existing wading pool which will be relocated as described above.
- Opposite the wading pool area, create a broad lawn area with a few canopy trees to provide shade and scale. Tree selection should consider species that produce minimal vegetative "litter" during the pool season.

- Resurface a significant portion of the fenced area with concrete paving. Maintain paving along the perimeter of the courtyards and pavilion wings to facilitate use of these spaces.
- Provide colorful shade structures throughout the deck area.
- Consider replacement and/or repair of the existing perimeter fence. If replaced, the fence should remain as a black ornamental fence.

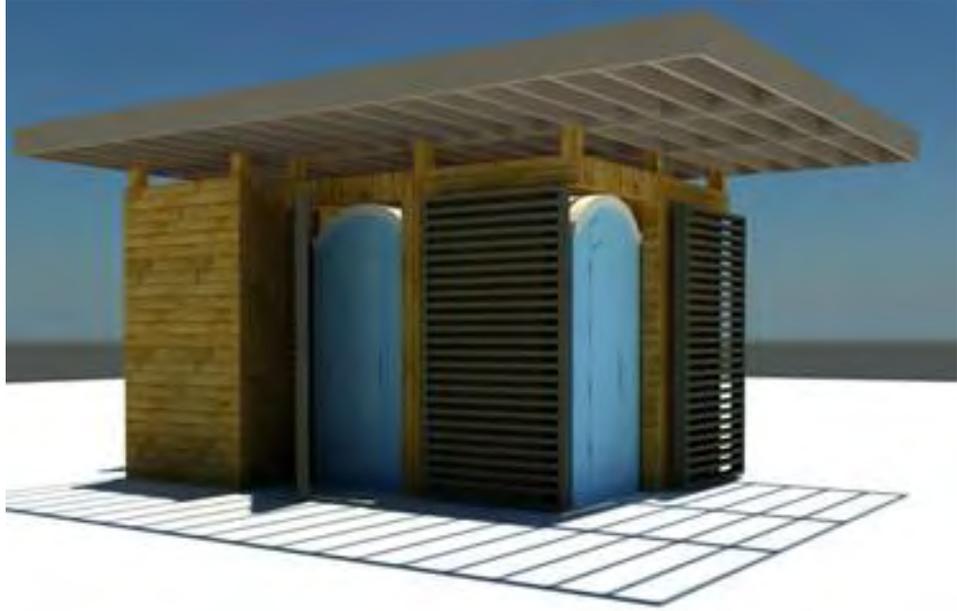
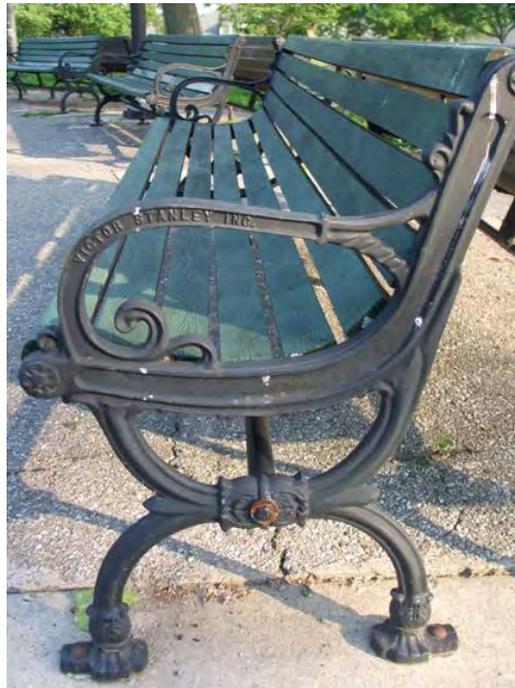
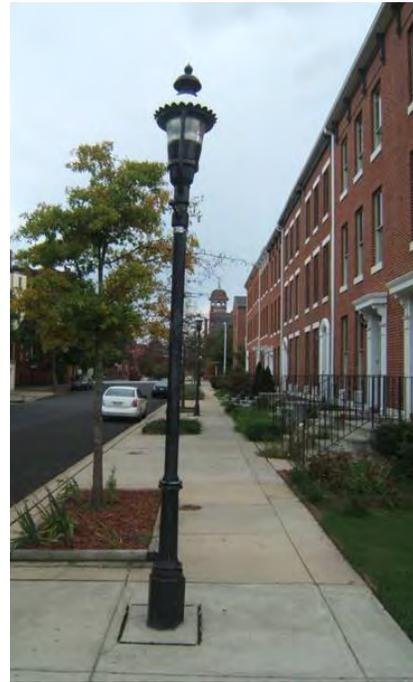
*The above photograph (top) shows a potential portable restroom enclosure. The middle photograph (left) shows the historic benches that should be maintained and repaired near the pavilion and the bottom photograph shows the new Baltimore City park bench standard which will be used in other areas of the park. The middle photograph (right) shows the "Bolton Hill" light fixture to be used throughout the park.*

- **Ornamental Lighting (#22):** Provide ornamental lighting (“Bolton Hill” fixture) throughout the park.
- **Site Furniture Replacements (Throughout Park):** Replace benches (with exception of those ringing the pavilion) with the new BCRP standard bench and replace trash receptacles with the new standard.
- **Tree Planting (Throughout Park):** Plant additional trees (emphasizing long-lived, native canopy trees) in accordance to the Riverside Park Tree Master Plan to provide replacements for maturing trees and to continue to reinforce open lawns.
- **Open Lawns:** Preserve existing open lawns and flexibility for passive play by avoiding tree plantings in these areas, as identified in the Riverside Park Tree Master Plan.
- **Park Signage:** Implement new park signage throughout the park using new BCRP standards.

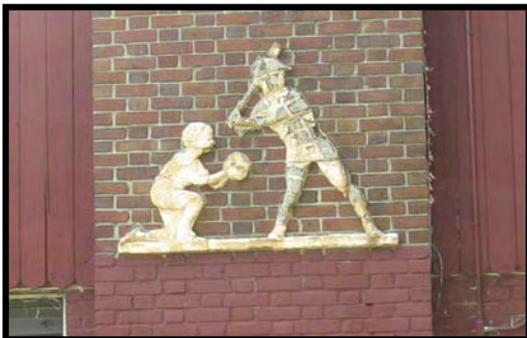
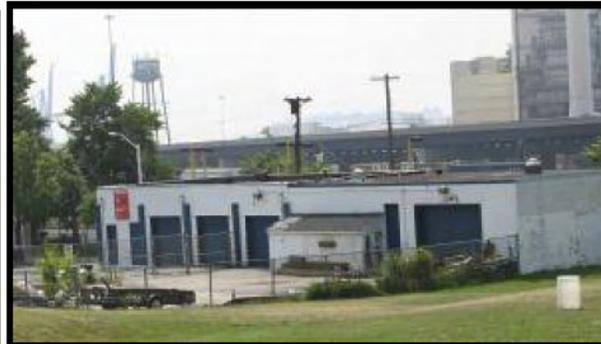
**Figure 5 and 6. Bas-relief located on west façade of the athletic field house (left); and maintenance shop (right).**

The athletic field house, located southwest of the pool complex and directly north of the baseball field, has also lost significant historic integrity. The porch floor, posts, and ceiling trim are all new materials. Doors, windows, door and window openings have all been compromised. Red plywood has replaced the original side gable sheathing materials. On the west façade, a severely deteriorated bas-relief of children playing baseball is located on the chimney.

In addition, the maintenance building, located in the southeast corner of the park, is not historic.

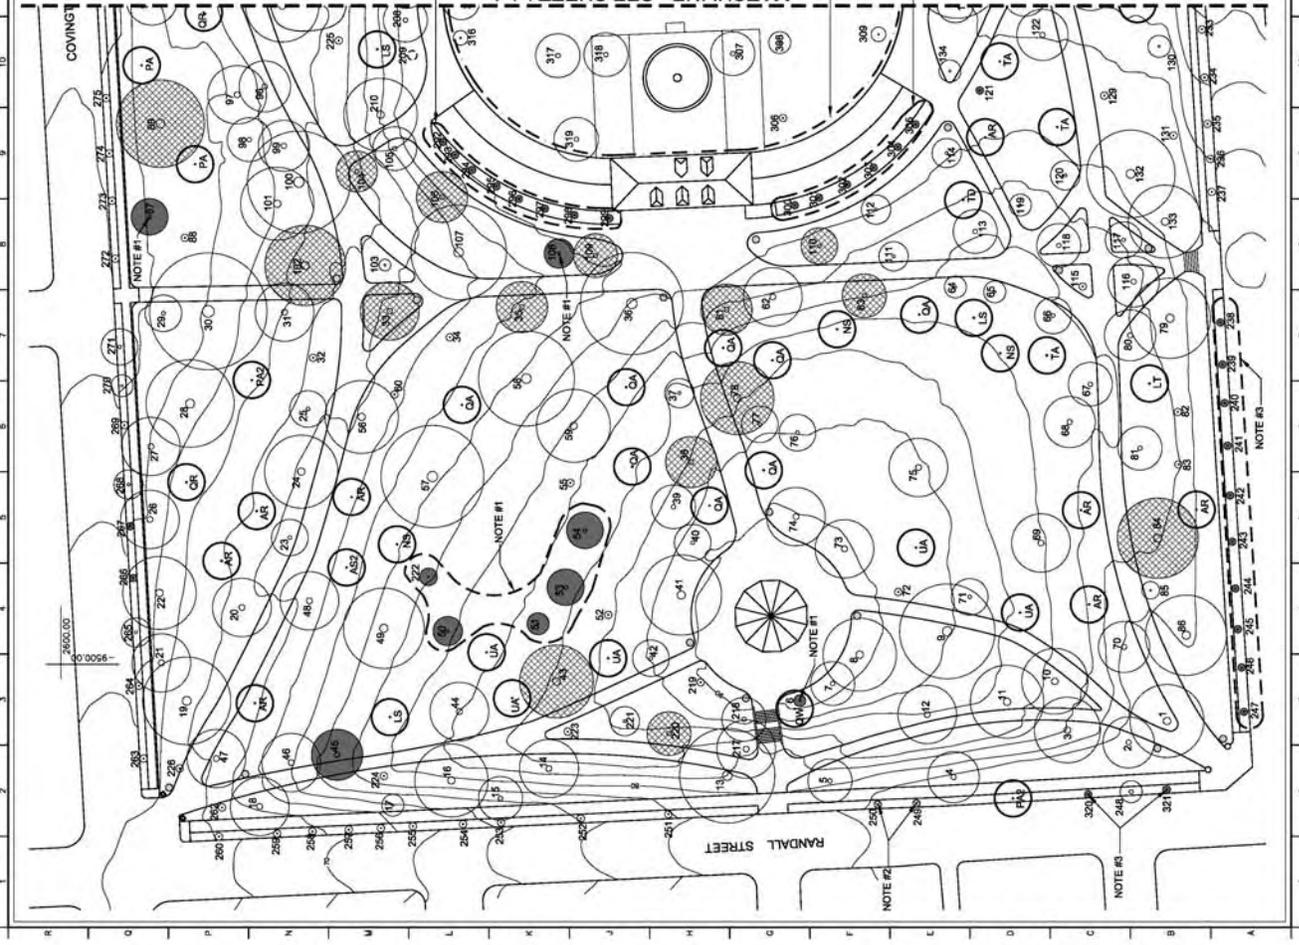
1. TREES ARE HEALTHY BUT INAPPROPRIATE FOR THE SITE. REMOVE TO ALLOW FOR OPEN LAWN AREA DEFINED BY TALL CANOPY TREE AND BROAD LEAF TREES.
2. REMOVE SOPHORA INCLUDING THOSE WITHIN THE POOL AREA AND OTHER INAPPROPRIATE SPECIES AS THEY BEGIN TO DECLINE AND REPLACE WITH OAKS AND MAPLES.
3. REMOVE AND DO NOT REPLACE. OVERHEAD UTILITIES REQUIRE LOW CANOPY TREES WHICH WILL BLOCK VIEWS INTO THE PARK.
4. AS SILVER MAPLES, ELMS AND ASH DECLINE IN THE PARK, REPLACE SILVER MAPLE AND ELMS WITH NEW DISEASE RESISTANT ELMS; REPLACE ASH WITH LINDENS AND TULIP POPLARS.

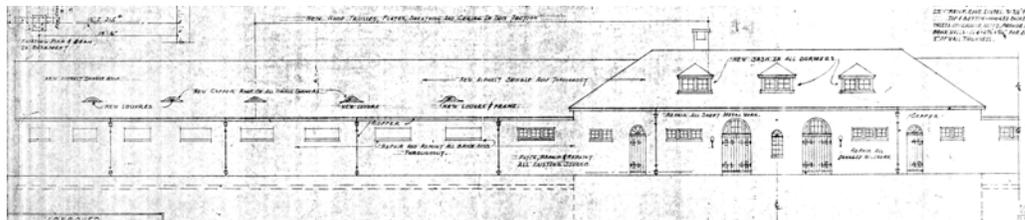
Fig. 1: Partial Exterior North Elevation from the 1949 renovation drawing set.

*East and West Wings:* The stucco surfaces are in salvageable but deteriorated condition, with areas of cracking and a few areas of missing stucco. The stucco has been painted several times, and the paint is peeling and cracking away from the surface of the stucco. The wings were not re-roofed during the c1998 renovations, and the asphalt shingles, perhaps dating to the c1949 renovations, are in poor condition. There are no gutters on the wings, and several holes have developed in the roof sheathing near the gutter line, especially on the south side.

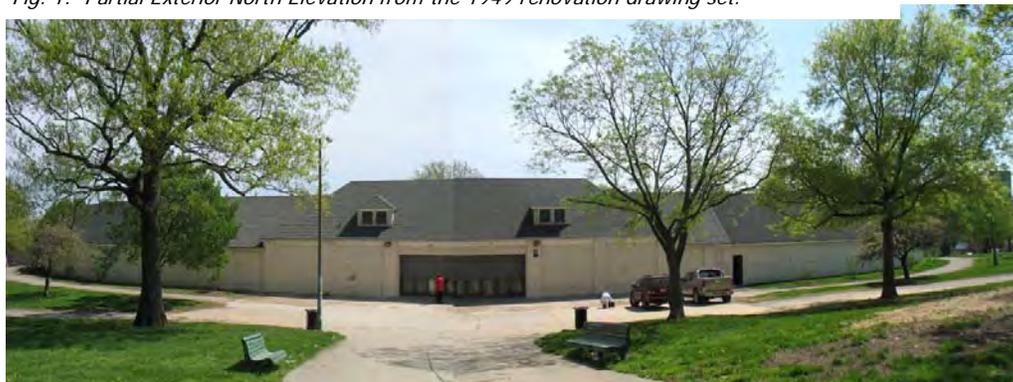
Fig. 2: North Elevation, May 2009 photograph, GWWO. The central portion was entirely rebuilt in c1998; the flanking wings on either side were left with their 1949 renovations and closed to the public.

*Central Portion:* New wood roof trusses with plywood sheathing, and new asphalt shingle roof were installed in the c1998 renovations. The exterior wall cladding material appears to be an EIFS system (Exterior Insulation Finish System), colloquially known as "Dryvit." It is unknown whether the substrate below the EIFS is the original clay tile wall system of the mid-1920s, or a new framing system (the walls are hollow sounding when tapped). The condition of the EIFS on the north elevation is poor. The material is being compromised by what appears to be Lacrosse or tennis practice. Apparently, players are using the wall surface, which looks like a solid masonry surface, as a backstop for rebound shots, facilitated by the wide concrete sidewalks that flank this area of the building. The insulation below the stucco is not sufficiently rigid and is being crushed with the impact of the balls.

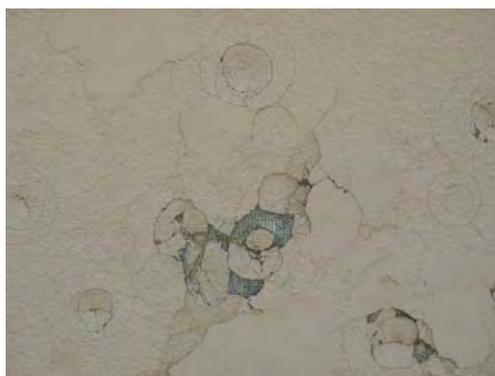
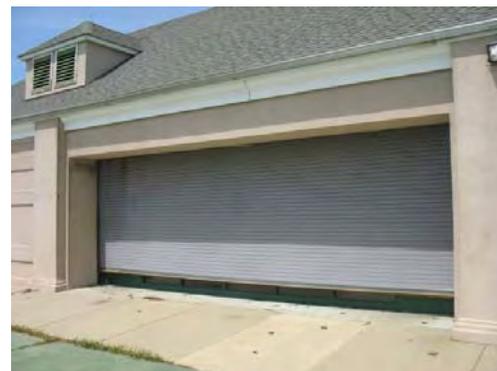
Figs. 3, left; and 4, right. Left: EIFS surface on North elevation of the central portion of the Pool house. Ball practice is causing damage on the surface of the stucco. Right: Central wing, south elevation; the manual-operated coil down door is currently unable to fully close.

The door areas of the north and south side of the central wing are protected by large rolling down steel doors, manually operated. The facility operator has experienced some difficulty in achieving full closure of the doors. A total of four ventilation dormers are located in the central wing, which appear to be in good condition.

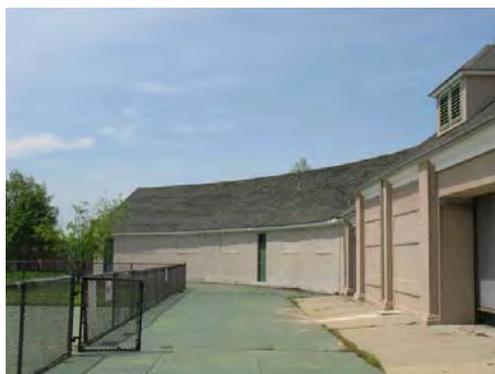
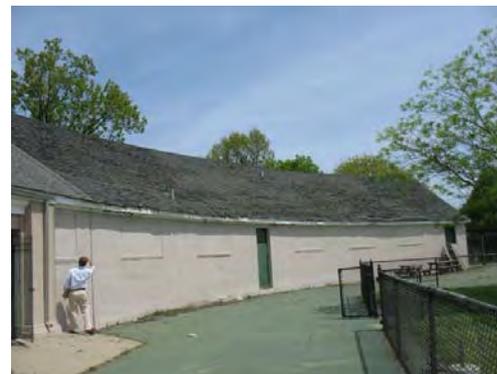
Figs. 5, left; and 6, right. Left: West wing, south elevation. Right: East wing, south elevation.

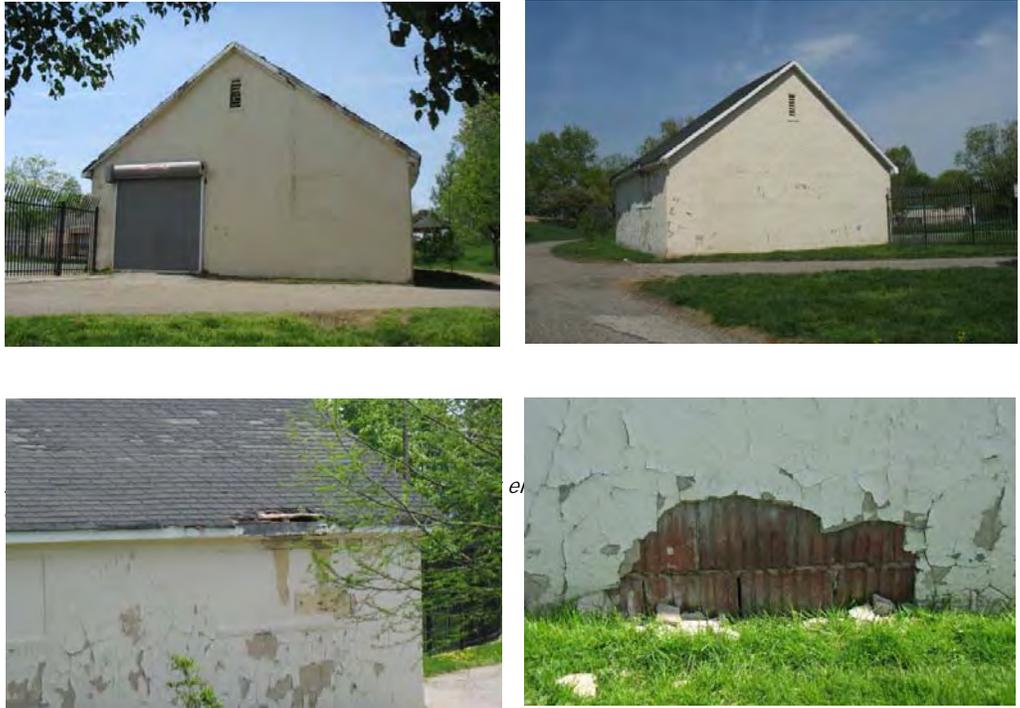
*Figs. 9, left; and 10, right: Left: Detail at wall and roof of East wing, south side, showing plaster condition and damage to roof sheathing near gutter (missing). Right: West wing, north elevation, showing an area where the stucco is delaminating and actually missing from the back-up clay tile wall system.*

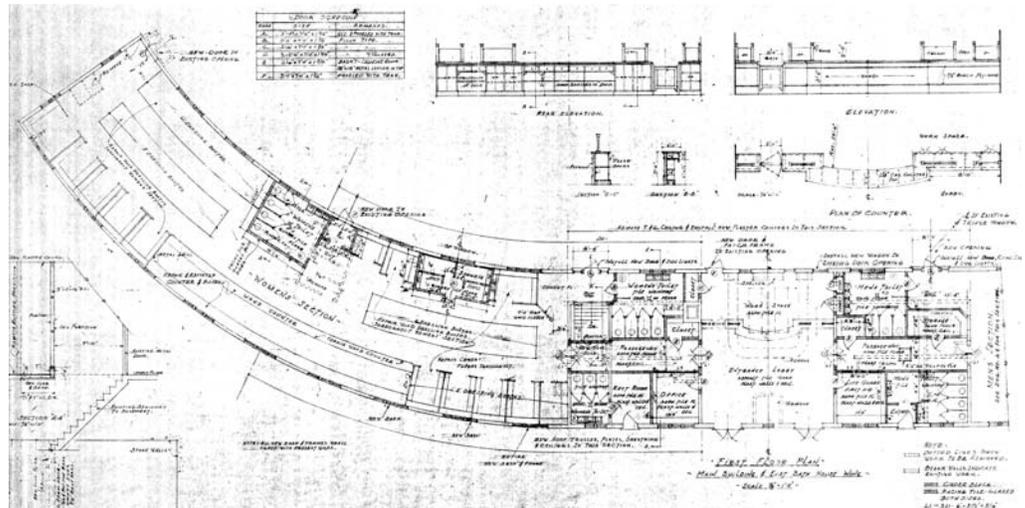
Fig. 11: Partial Floor Plan, central portion and east wing, from the 1949 renovation drawing set. The current interior layouts of the wings are primarily as shown on this drawing

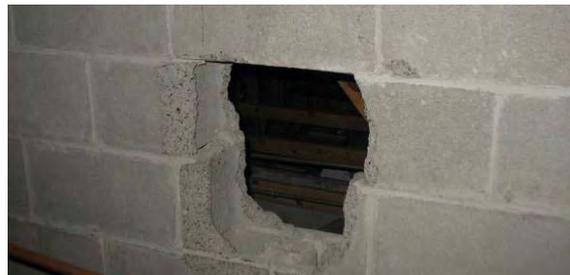
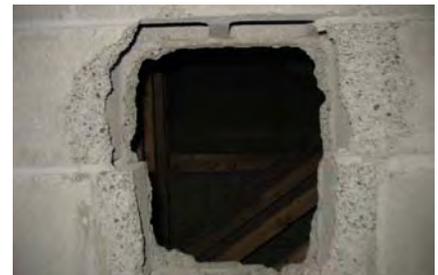
Figs. 12, left; and 13, right. Views in the roof truss area. Left: unprotected access hole through fire wall on west side. Right: unprotected access hole through fire wall on east side.

**Central Portion:** The central portion of the pool house was entirely reconstructed in c1998. The condition on the interior is generally good. The roof structure is new wood trusses with plywood sheathing. Two fire walls of concrete masonry units (cmu) separate the central portion of the pool house from the east and west side wings. Each one has an unprotected access hole that should be protected with a fire-rated enclosure.

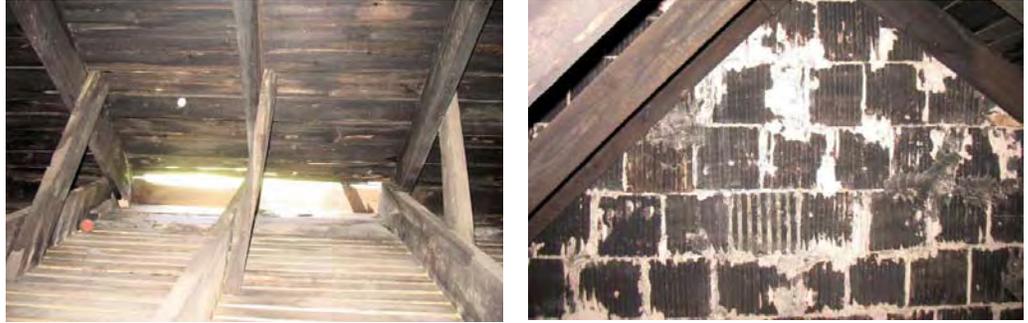
*Figs. 16 left; and 17, right. Views in the roof truss area, West Wing. Left: damaged and missing sheathing, north side of west wing, near end wall. Right: clay tile gable end wall.*

Between 10 and 12 trusses (a relatively small quantity given the total roof span) appear to be damaged and will need to be sistered or replaced. Similarly, approximately 10 percent of the roof sheathing is rotten, deteriorated, or missing and needs replacement. This is especially true in the lower portions of the roof, near the eave line, where typically about 1'-6" of sheathing should be replaced. There appears to be a localized, 5-bay area of termite damage in the East wing, approximately 20' in from the end wall on the north side. Member replacement would be recommended for portions of the framing and sheathing in this zone. Some areas currently have an infestation of ants. Squirrels are living in the East wing attic.

The wiring in the attic is run in galvanized steel conduit and the roof is not insulated. The trusses sit on a double-wythe clay tile wall construction. The inside tile wall is 8" thick, and then there is an approximate 4" air cavity. The outer wythe appears to be 4". A wood plate caps the wall, 2-1/2" by 7" actual. A horizontal iron tie member runs at the top inner side of the outer wythe of wall. The windows are blocked by interior shutters that are currently closed. Where we could see into the shuttered area, it appears that the window sash is still in place.

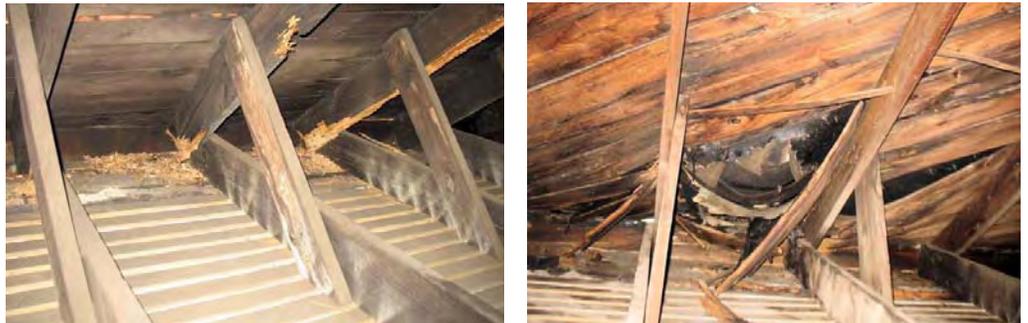
*Figs. 18 left; and 19, right. Views in the roof truss area, East Wing. Left: termite damage at north side; extent extends approximately five bays. Right: water damage to sheathing, and missing sheathing, south side.*

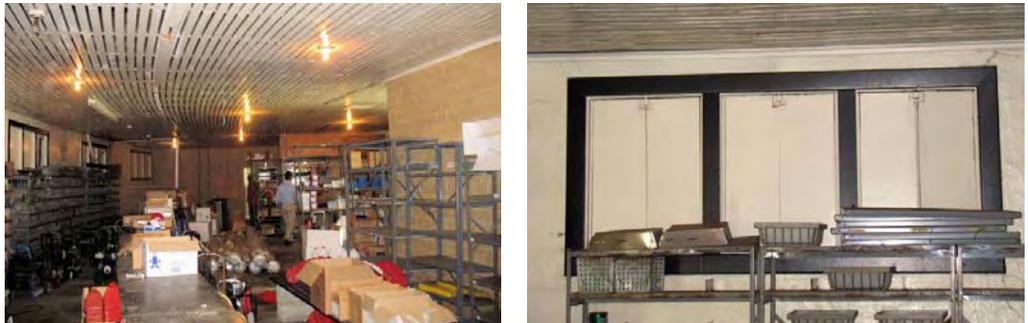
*Figs. 20 left; and 21, right. Views in the first floor area, West Wing. Left: view looking west, showing open space and wood-slat ceiling. Right: detail at interior wood shutters, in closed position.*

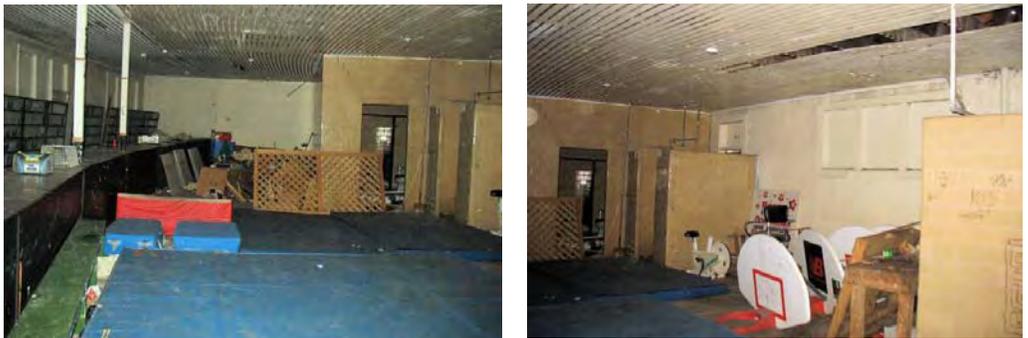
*Figs. 22 left; and 23, right. Views in the first floor area, East Wing. Left: general view looking toward southeast end wall. Right: general view looking toward south wall. Several areas of ceiling slats require work.*

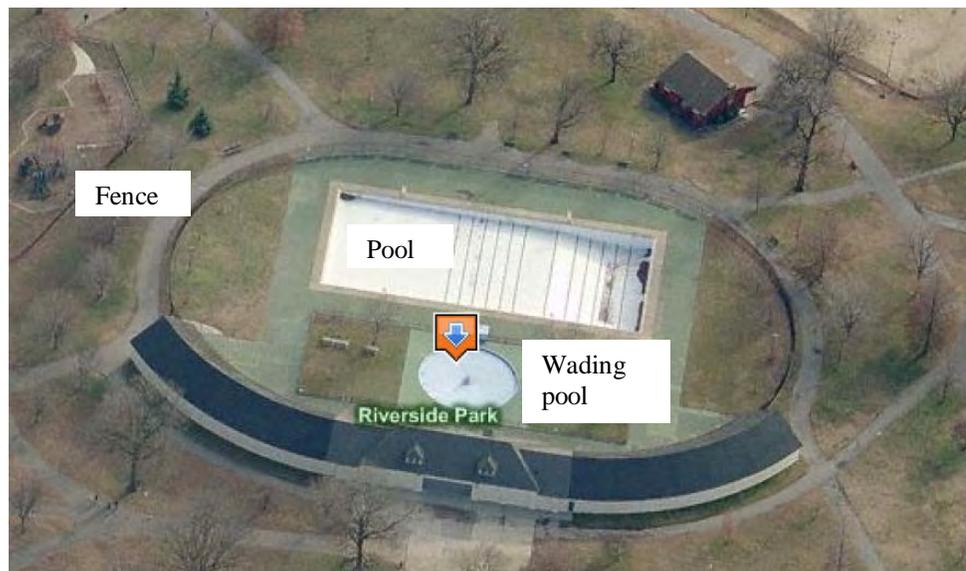
*Image 1 - Pool complex from above*

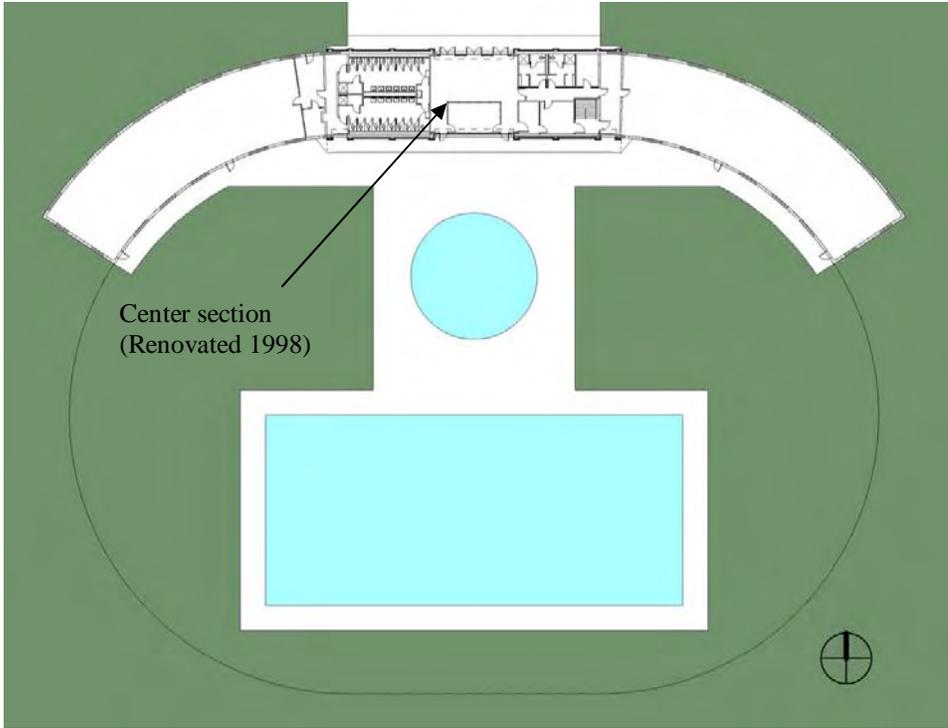
Image 2 – Existing Pool Building Plan

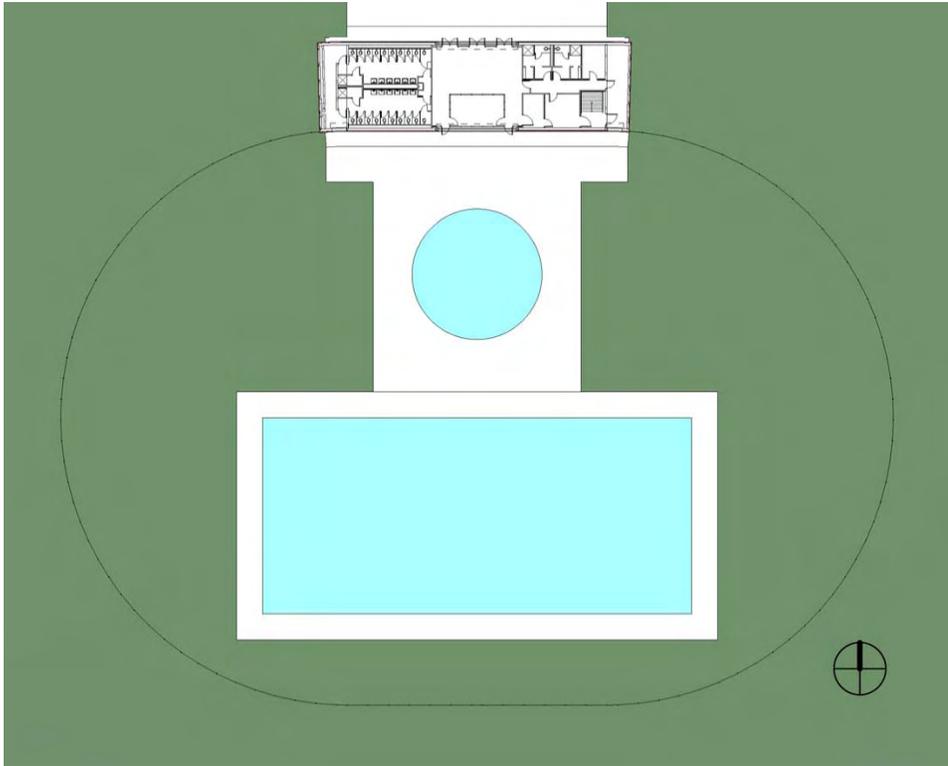
Image 3 – Pool Building with Wings Removed

***Option 1: Demolish Wings (Rejected):*** Option 1 explored the proposal to demolish the flanking wings leaving only the central rectangular section of the pool building. This scheme was rejected because removal resulted in a loss of both aesthetic value and usable space. One of the complaints about the pool building was that from the park side, it concealed the pool from view. From the pool side however, the wings create enclosure and definition for the space.

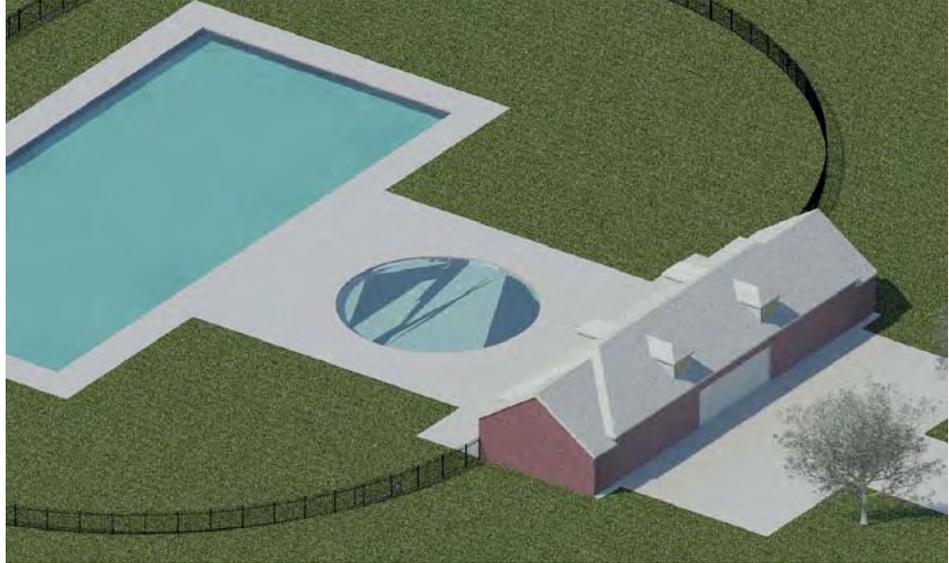
*Image 4 – Northeast bird's-eye view showing building re-clad in brick with wings removed.*

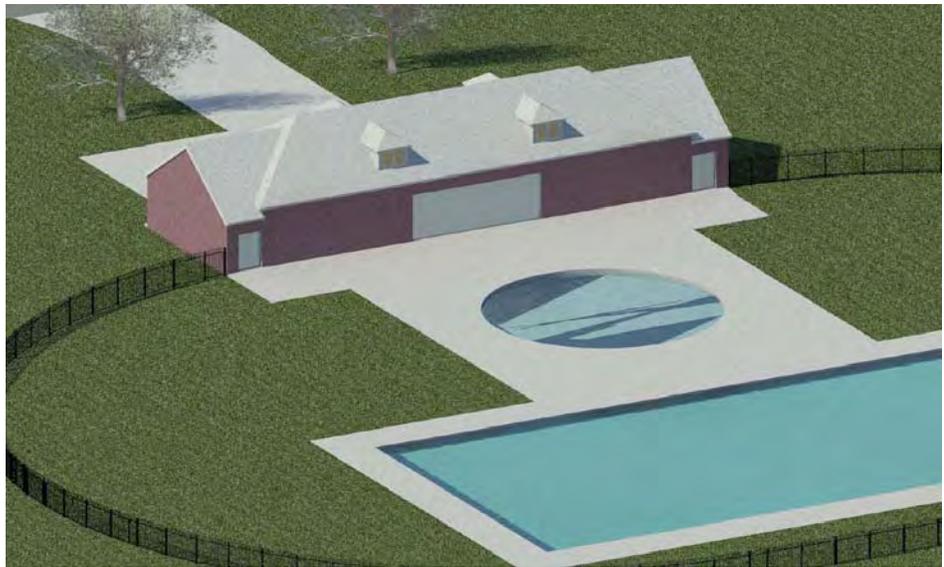
*Image 5 – Southwest bird's-eye view showing building re-clad in brick with wings removed.*

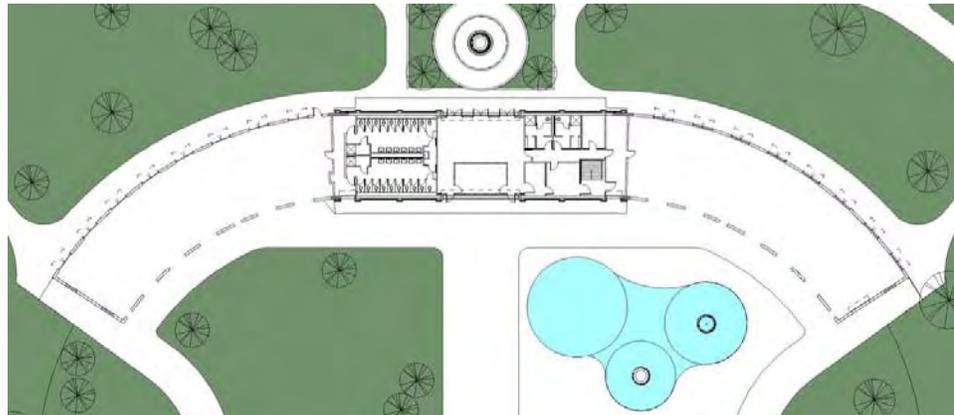
*Image 6 – Option 2 plan showing doors and walls below existing windows removed. Openings are gated at park side.*

**Option 2: Create New Gated Openings at Existing Blocked Up Windows (Rejected):** Option 2 explored salvaging the existing wings and creating new openings. Refer to picture below. The rectangles on the wing wall are former window openings which are blocked up. In option 2 the window infill would be removed and the walls below cut out. The existing window headers would provide the necessary structure for the openings. At the pool side the existing doors would also be removed and the openings would remain. The failing roof would be replaced and damaged plaster repaired. The scheme was ultimately rejected because the community felt that the renovated space inside the wings was dark and unwelcoming.

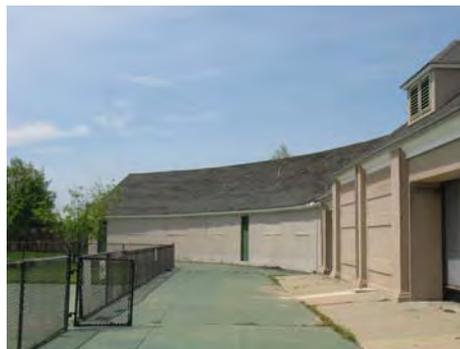
*Image 7 – Photograph taken at existing pool deck looking west.*

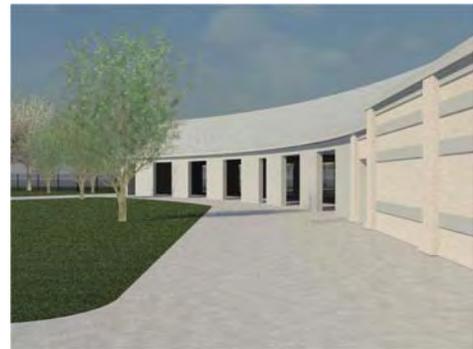
*Image 8 – Rendered image of Option 2. Same view as Image 7 at left. Existing doors and walls at original window openings have been removed.*

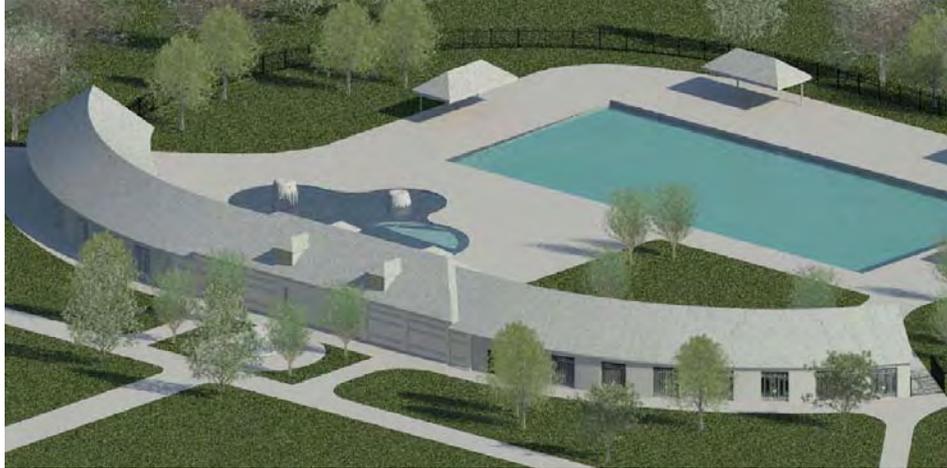
*Image 9 – Northwest bird's-eye view of Option 2. Walls at existing window locations have been removed and openings are gated at park side.*
