# Riverside Park

## Master Plan

**Baltimore City Department of  
Recreation and Parks**

**Mahan Rykiel Associates, Inc.  
GWWO Architects, Inc.**

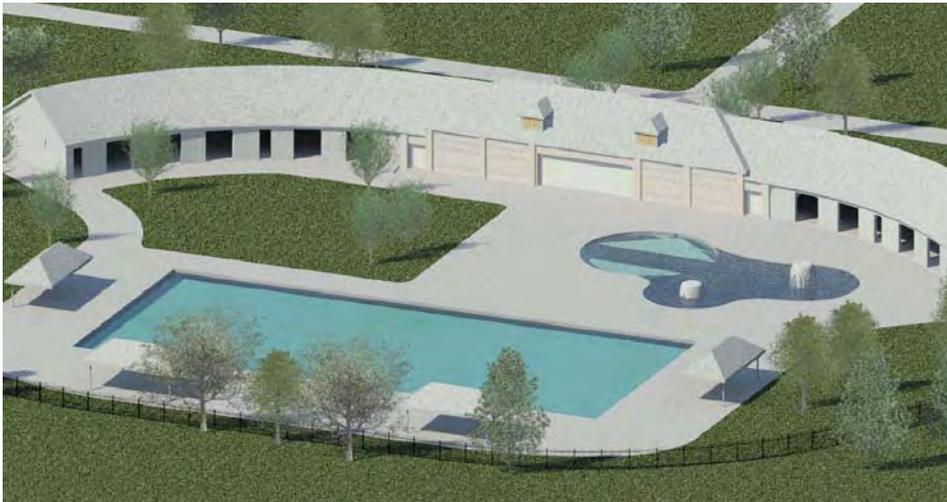
*Image 10 – Southeast bird's-eye view of Option 2. Existing doors and walls at existing window locations have been removed. Images 8 and 9 also show renovations of pool area which are discussed in the landscape section of the package.*

**Option 2: Create New Gated Openings at Existing Blocked Up Windows (Rejected):** Option 2 explored salvaging the existing wings and creating new openings. Refer to picture below. The rectangles on the wing wall are former window openings which are blocked up. In option 2 the window infill would be removed and the walls below cut out. The existing window headers would provide the necessary structure for the openings. At the pool side the existing doors would also be removed and the openings would remain. The failing roof would be replaced and damaged plaster repaired. The scheme was ultimately rejected because the community felt that the renovated space inside the wings was dark and unwelcoming.

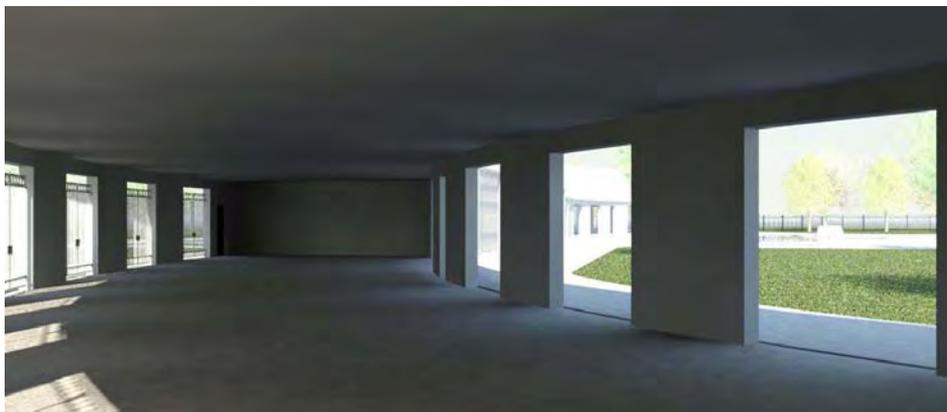
*Image 11 – Interior view of Option 2. This image is taken from west pavilion looking east. Existing doors and walls at existing window locations have been removed. Existing ceiling and floor slab remain.*

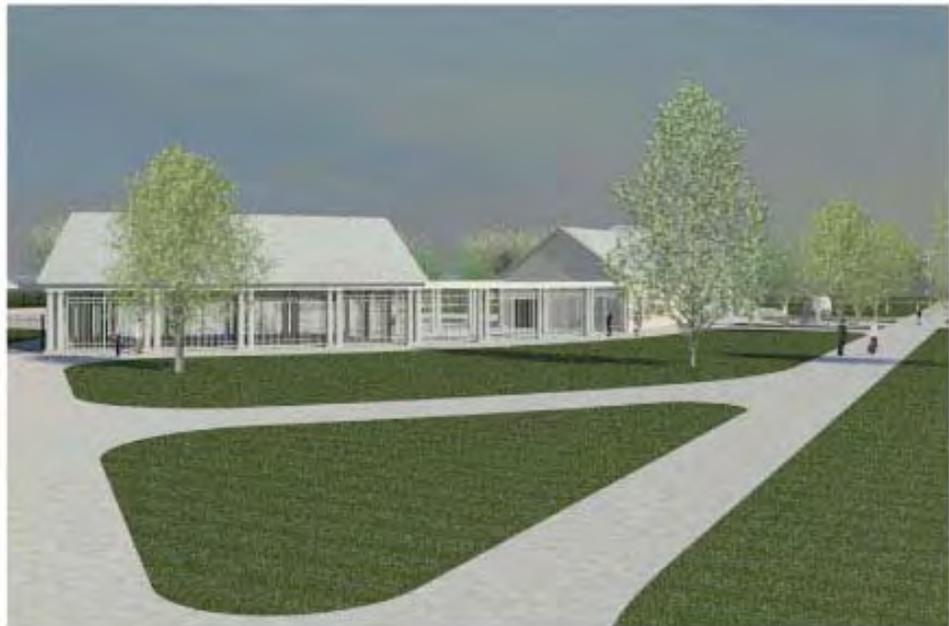
*Image 12 – Outside view of new pavilion and colonnade.*

Option 3 preserves the existing form of the pool building but replaces the curved wings with pavilion spaces of similar size. The center section of the existing building housing the bathrooms and lobby would remain and be re-clad in a more durable material. Some of the roof and floor structure of the wings might be salvaged in the process, but existing curved wing walls would be entirely demolished and replaced with a new colonnade. The new wings would be broken into three sections with the inner and outer sections roofed and the center section open to the sky. The open area could be planted or paved. The covered areas could be utilized as shaded areas for tables and games during normal pool use and could also be rented by groups for parties. Gates would allow the pavilion spaces to be used from either the pool side or park side depending on season and function. A small section of building adjacent to and on both sides of the remaining center section would serve as storage for the facility. The storage spaces would be divided in half with both exterior and interior access. The exterior accessed portions would serve as tool storage for park volunteers. The interior spaces would serve as general storage for the pool. This scheme offers shade, shelter, and rentable space, while providing more transparency between the pool complex and the park.
